STRUCTURAL ASSESSMENT AND CONDITION SURVEY

Water-Cum-Jolly Footbridge, Cressbrook, SK17 8SA

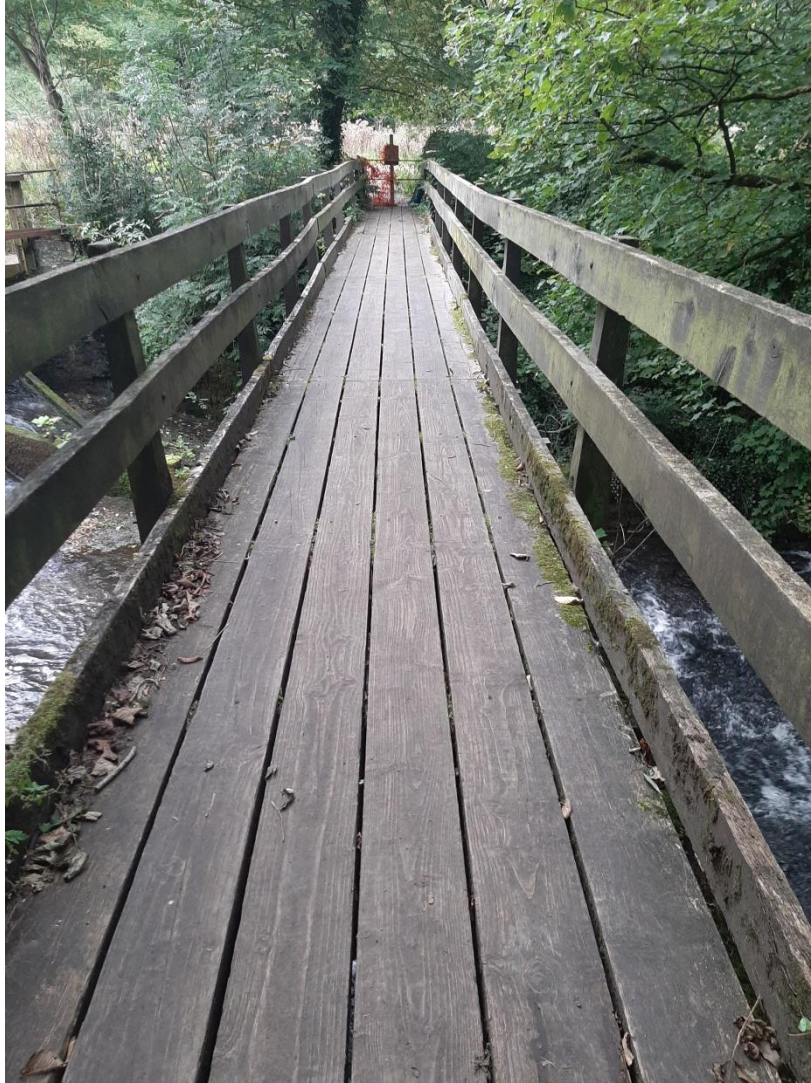
View looking from the Western end

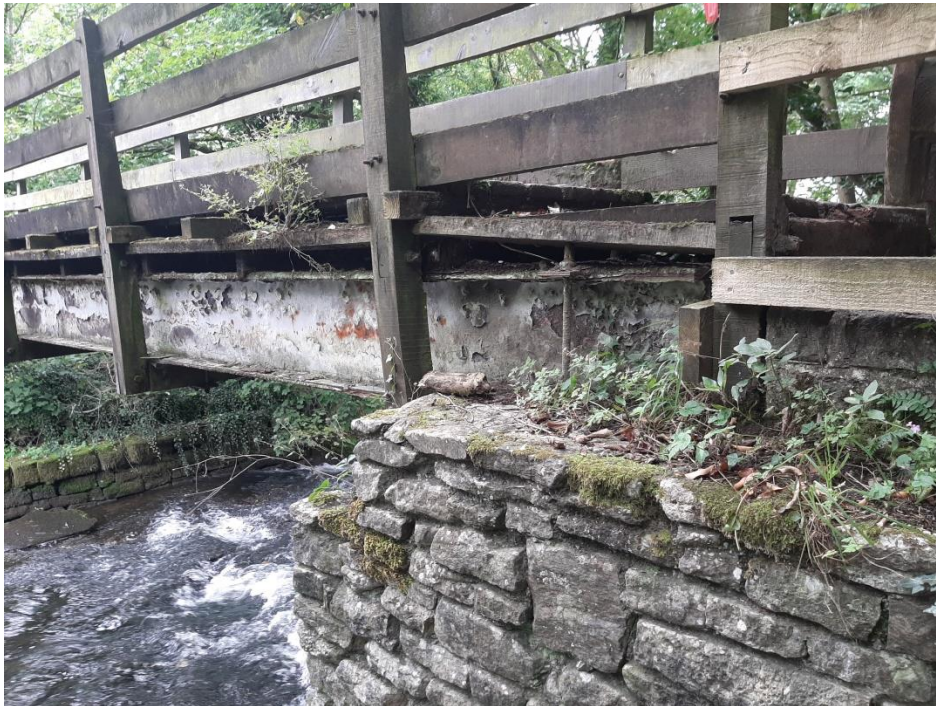
View at Western Abutment showing deck build-up

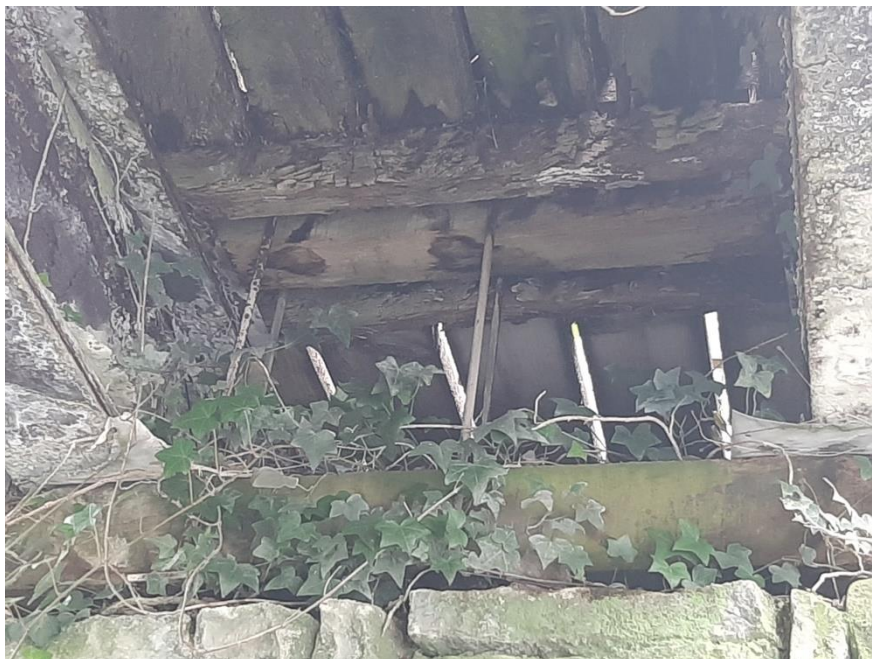
View at top of Pier showing deterioration of timber

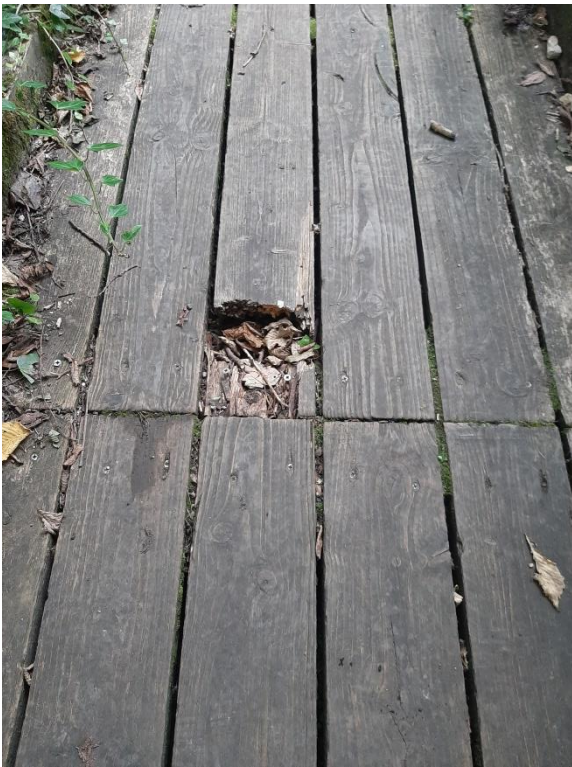
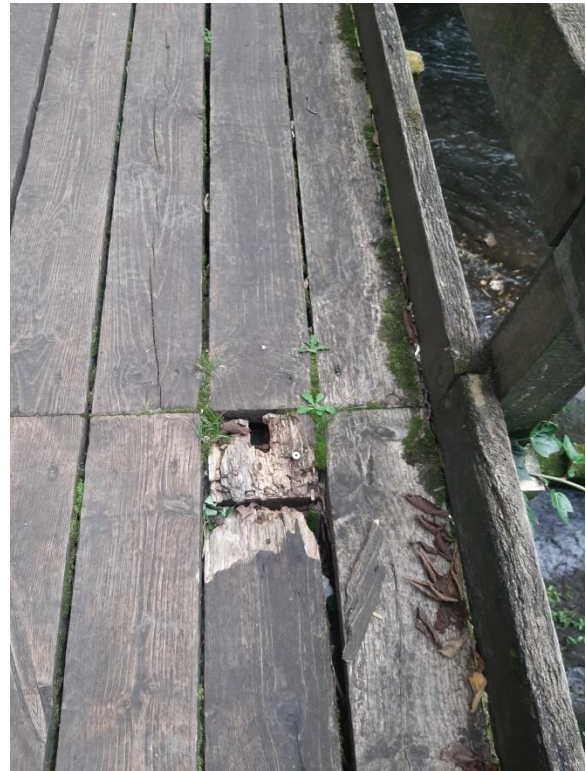
Generally, the more recent timber boards were in reasonable condition. However, some isolated boards were noted to be rotten at the ends, and were not securely fixed to the joists below in these locations. Whilst being unsafe due to their lack of fixity, they also present a trip hazard.

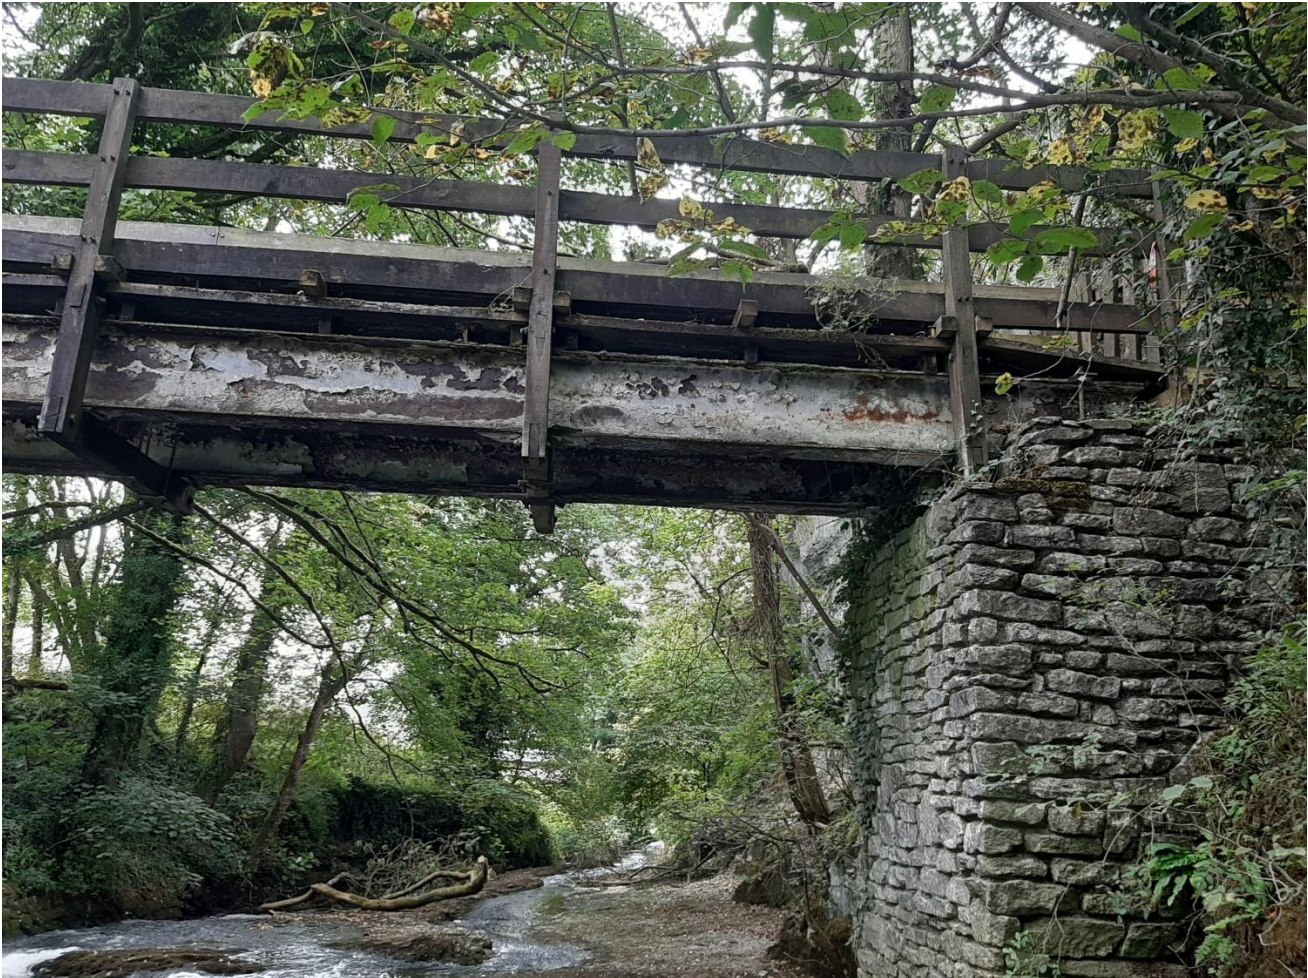
View looking towards the Western Abutment – flaking paintwork on steel

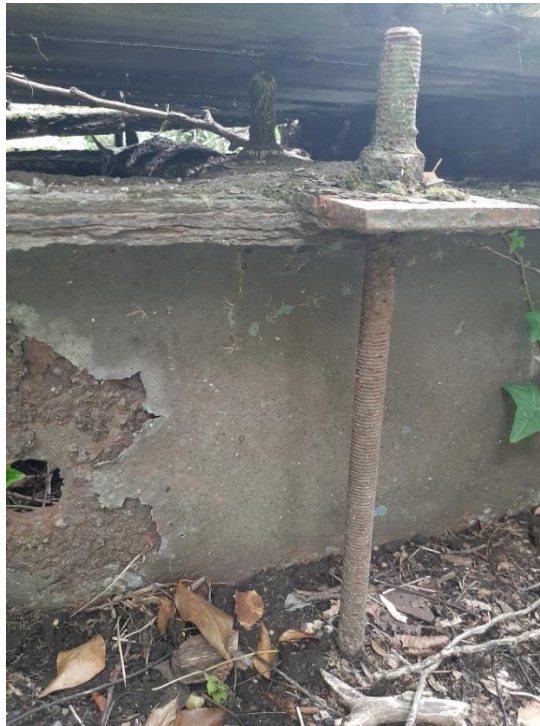
End of southern beam on Western Abutment – delamination of steel (top flange)

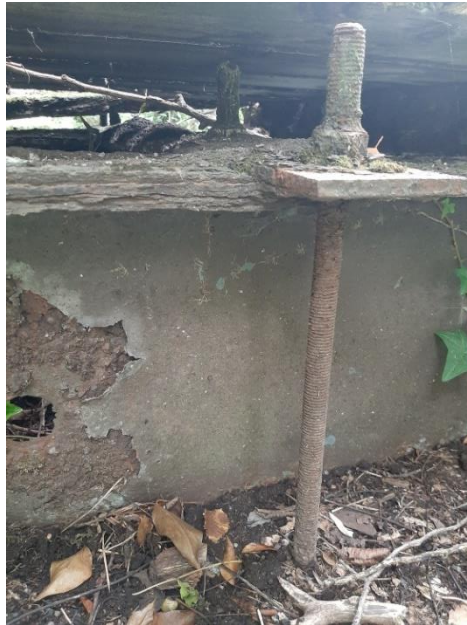
Bridge beam support fixing – Western Abutment, southern side

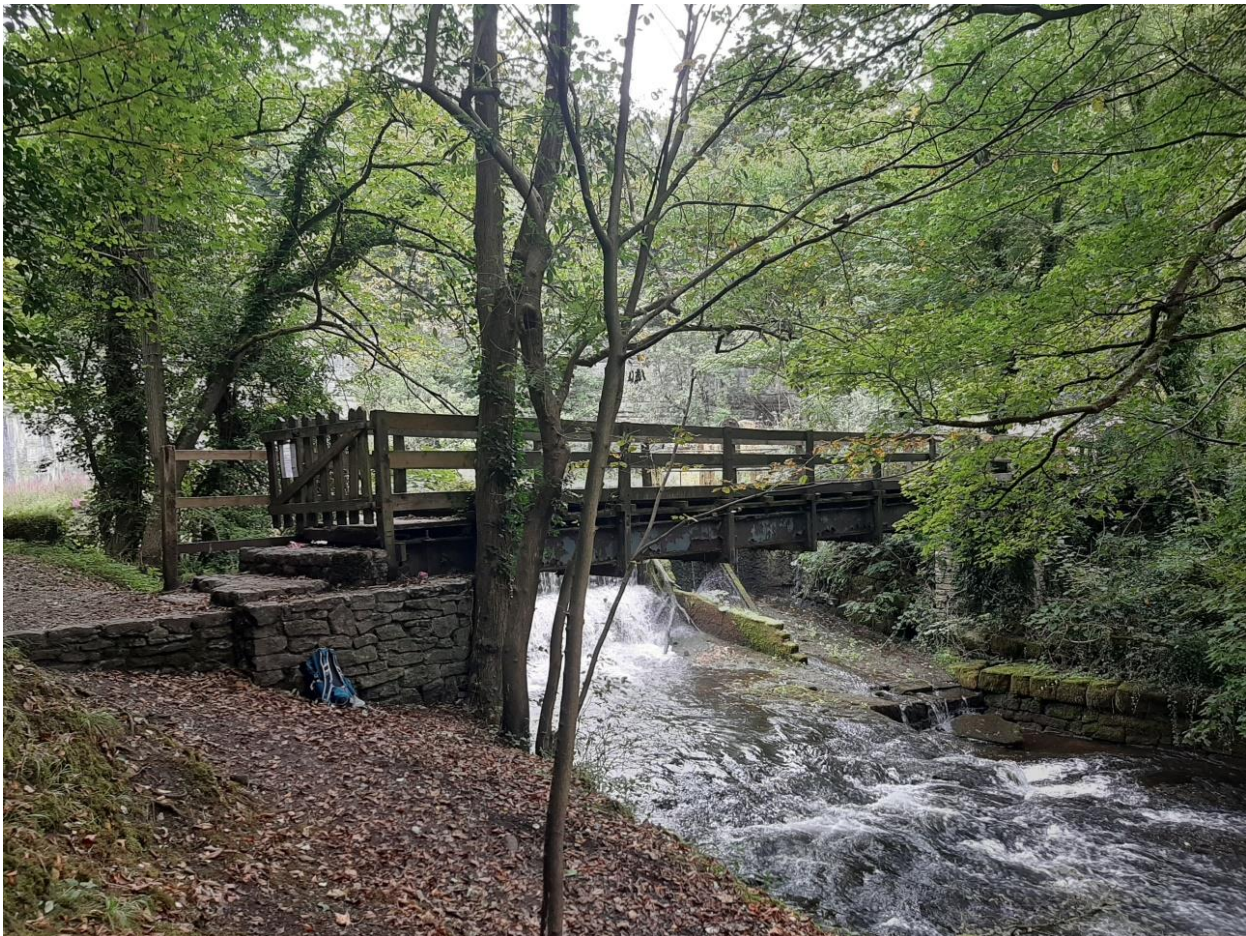
View from the south, on the western bank

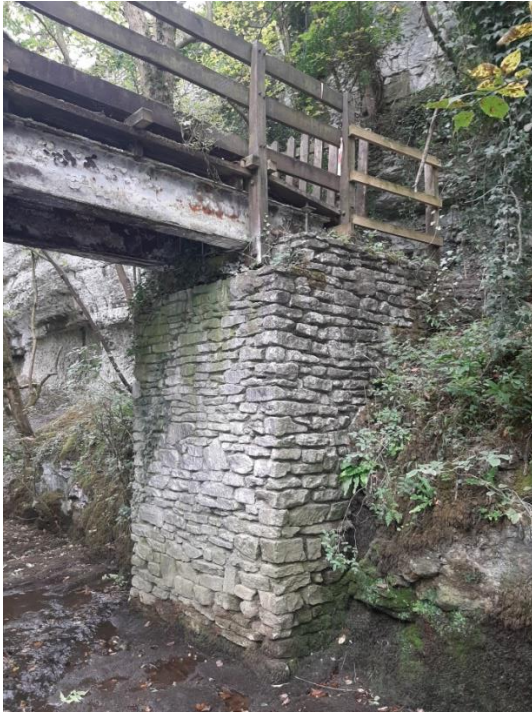
The abutment is built directly off underlying natural rock forming the river bed. Other than vegetation around the southern edge penetrating mortar joints, the structure appeared to be reasonably sound with no visual signs of distress. However, localised deterioration may have occurred where roots have penetrated the structure. Until vegetation is removed, it is not possible to determine the extent, if any.

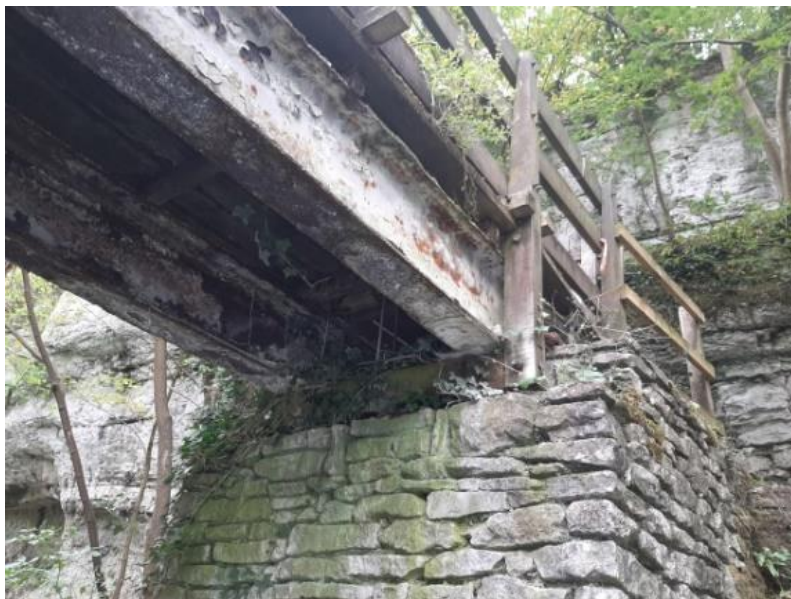
Recess at top of Northern face of abutment

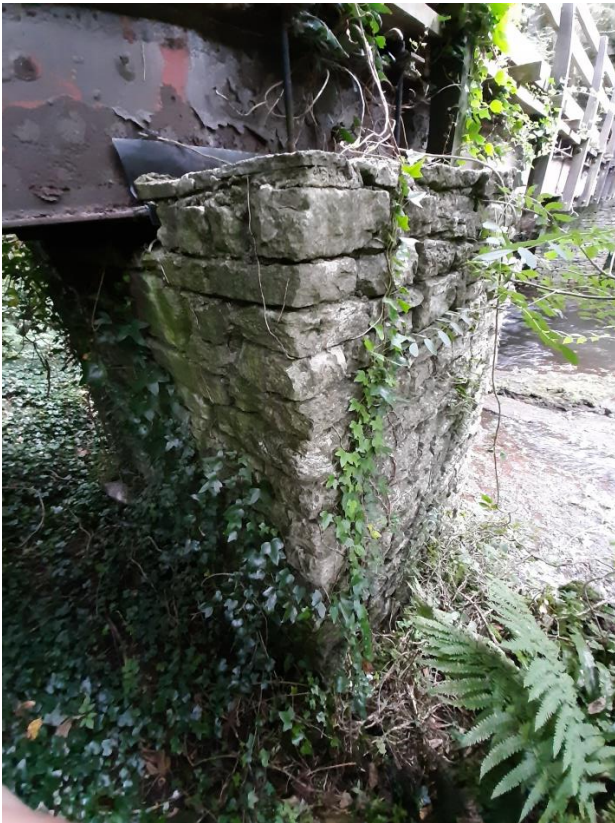
The pier was noted to be overgrown with considerable vegetation around each face. This creates the risk of roots penetrating the joints, leading to possible localised damage of the structure. Vegetation will need to be removed in its entirety to allow a more thorough structural inspection.
