THORNSEAT LODGE

Mortimer Road, Low Bradfield, South Yorkshire

Heritage Statement

October 2022
Final v6.1

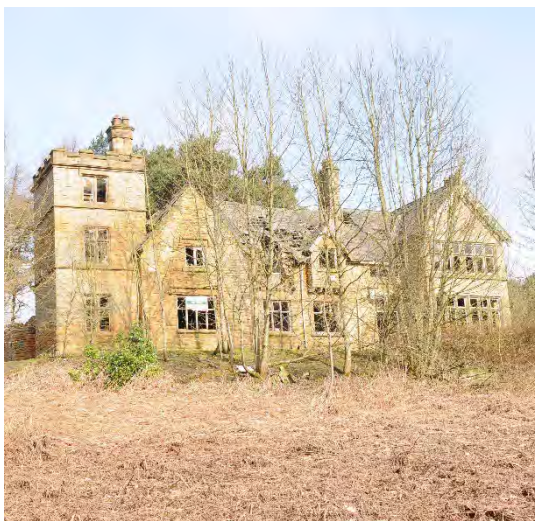
THORNSEAT LODGE	BUILDING I
<p>Designation</p> <p>Non-designated</p>

<p>Primary Phasing</p> <p>Built c.1853 for Sidney Jessop as a shooting box. Extended c.1900 by William Jessop with the construction of an additional bay and rear service wings.</p> <p>Minor alterations to layout during occupation as a children's home in the mid to late 20th century and gradual decline and ruination since becoming disused.</p> <p>See Figure 3 for phase plan</p>

The building is in a very poor condition and at severe risk of further collapse unless works to stabilise the structure are undertaken. The majority of the roof has lost its coverings and has largely collapsed. Internal joinery, including stairs, floors and ceilings, have also all collapsed. Areas of walling have fallen out, and structural steels used to support first floor walls above larger ground floor rooms show signs of severe corrosion. External windows are all incomplete, and most have lost their glass.

The conversion of Thornseat Lodge (**Building 1**) seeks to restore and conserve the external envelope of the building, including the replacement of missing masonry, fenestration and roofing to match extant historic fabric or as evidenced from historic photographs. The renovation will include limited changes, principally around the arrangement of access in the southwest elevation where two new doors will be introduced and an earlier door blocked; and the north elevation where a window will be replaced with a new door and window and a new extension built from the western part of the elevation. New doorways have been designed to reflect the dimensions and split transom window of the principal historic door to the southeast elevation, although without the decorative hood moulding or inscribed monogram in order to preserve hierarchy. Whilst there will be a change to the historic appearance of the building, the scheme is considered to have taken a proportionate approach, in regards to its regional significance, in restoring its most important aspects and designing changes to be sympathetic and subservient to the original design. The present ruinous condition of the building has significantly affected the architectural interest of the building, with the degree of loss being such that it makes no more than a moderate contribution to its significance. In restoring the building to usable condition, and in conserving and enhancing its most important aspects the scheme makes a high contribution to the regional significance of the building, and the proposed works will have a **positive effect**.

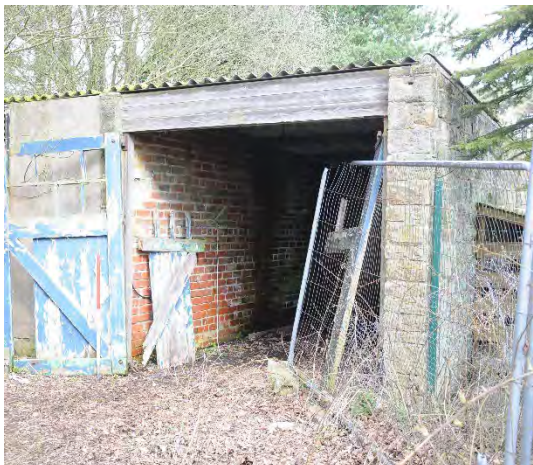
GARAGE		BUILDING 2
Designation Non-designated

Primary Phasing Built between 1930-1960.		
Description Single storey structure (Appendix 2.14) constructed of squared sandstone blocks laid to courses, with internal brick face and central brick dividing wall creating two rooms including a garage and store. The southeast elevation has the remains of a double door to the garage. The door to the store has been altered. The roof is clad in corrugated sheet.

The condition of the structure is generally good.

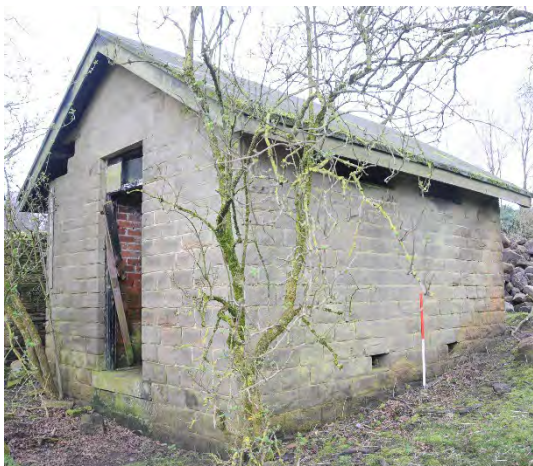
GAME LARDER		BUILDING 3
Designation Non-designated

Primary Phasing Built between 1890 and 1900		
Description The Game Larder (Appendix 2.26) is a small rectangular building with a pitched roof situated to the northeast of the Former Stables. The building is built of coursed squared sandstone with brick backing. The southeast elevation contains a central door, and there are high level slit windows situated under the eaves on the northeast and southwest elevations. Internally the building comprises a single room with chequer board quarry tile floor and glazed tiled walls. The jambs of the door and windows were panelled, although the architraves have been removed. The rafters are exposed into the ceiling, although there is evidence that this was once lathe and plastered.

Within the room are four sandstone piers, presumably legs from a removed stone topped table, or thrawl.

The condition of the structure is generally good.

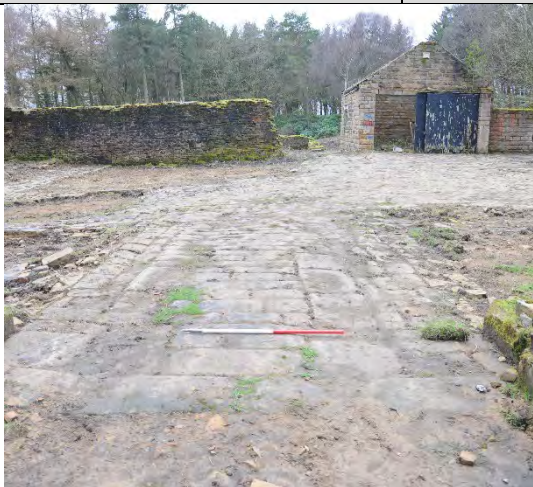
STABLE YARD		BUILDING 4
<p>Designation Non-designated</p>

<p>Primary Phasing Built c.1853 for Sidney Jessop.</p> <p>Alterations towards late 19th century to west and northern corners.</p> <p>The majority of the buildings were demolished in the mid to late 20th century.</p>

The Former Stables (**Appendix 2.18-20**) comprises a walled space measuring approximately 30 x 26m, surfaced with the fragmentary remains of a set paved yard and the foundations and interior floors of buildings that lined its northwest, northeast and southeast sides.

The building is largely demolished, and what remains is in differing levels of collapse. The building is not stable and there is risk of further collapse unless works to stabilise the structure are undertaken. The footings of the demolished buildings are visible at ground service and surfaces survive to a relatively good degree.

The new events venue will preserve the standing remains of the historic building, whilst impacting the fragmentary surviving surfaces, truncated walls and potentially any associated buried remains. This will have a **negative effect** on these archaeological remains of local significance. This effect can potentially be partially offset, to achieve a **limited negative effect**, by a suitable condition of planning consent for approval of foundation details to enable targeted preservation in situ of important remains and a watching brief during demolition/groundworks to secure preservation-by-record.

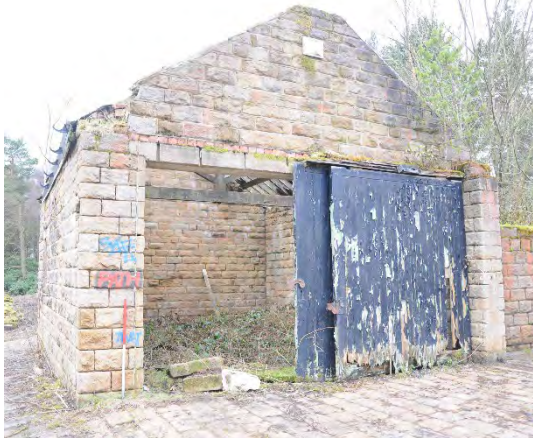
GRAIN STORE		BUILDING 5
Designation Non-designated

Primary Phasing Built between 1893-1903.		
Description <p>The Grain Store (Appendix 2.21-22) is situated on the southwest side of the Stable Yard. It comprises a rectangular gabled building of one storey. It is faced on the exterior and interior in regularly coursed rock-faced sandstone blocks. The roof has largely lost its covering, although a few blue slates survive in places. The roof is supported on a single king-post truss. A large vehicular entrance is situated within its northwest gable the jambs of the opening appearing original although the concrete lintel is an insertion. The only other opening is an inserted window in the southeast elevation.</p>

Internally the building comprises a single space open to the rafters. The room was evidently undecorated, and there is no evidence for plant of other fixtures or fittings to the interior faces of the walls.

The condition of the structure is currently fine, but the absence of the roof will lead to further decline.

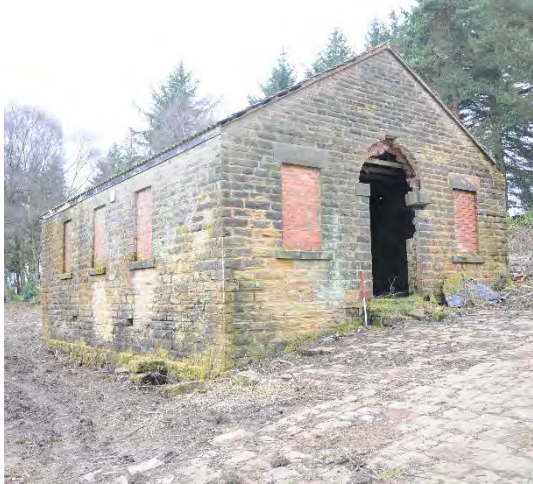
ENGINE ROOM		BUILDING 6
Designation Non-designated

Primary Phasing Built between 1930-1960.		
Description <p>The Engine Room (Appendix 2.23-24) is situated to the southwest of the Former Stables and comprises a rectangular gabled building of one storey. It is faced on the exterior in regularly coursed rock-faced sandstone blocks and on the interior walls in squared rubble, painted over with an emulsion. The roof is of concrete tiles supported on modern timber lattice trusses. The northeast elevation has a central doorway, accessed via three stone steps, with an arched head within which the stone voussoirs have been removed. The door is flanked by vertical rectangular windows with stone sills and lintels which have been blocked in red brick. Three windows of identical design, and similarly blocked, are also evenly spaced along the northwest and southeast elevations.</p>

Internally the building comprises a single space open to rafters. The floor along the northwest and southeast walls is of concrete, with a central strip of MDF sheets across timber joists. Within the centre of the western half of the southwest wall is a wide brick chimney breast with two fireplaces. A low brick-built wall extends into the room from between the fireplaces, parallel to the northeast wall.

The condition of the structure is generally good.

The repair and conversion of **Building 6** will preserve the historic fabric of the external walls of the structure and secure a new use that will ensure its long-term survival. The proposed gallery may require the replacement of the existing roof; however, this roof is itself a modern replacement and is not considered to be of heritage interest. Overall, this proposal will have a **limited positive effect** on the local significance of this heritage asset.

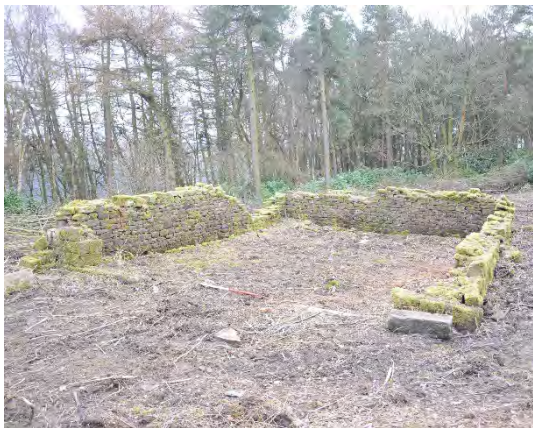
RUIN		BUILDING 7
Designation Non-designated

Primary Phasing Built between 1893 and 1903, possibly as the first engine house or cottage.		
Description Three stone-built walls survive comprising coursed squared sandstone external face and sandstone rubble backing (Appendix 2.25). The northwest and southeast elevations turn to form jambs on the northeast elevation, suggesting a wide opening. The building lies on the central axis of the stable yard, suggesting it may have been intentionally designed to be at least partially visible from the entrance into the stable yard.

There is potential for survival of sub-surface remains that could provide information on its original function.

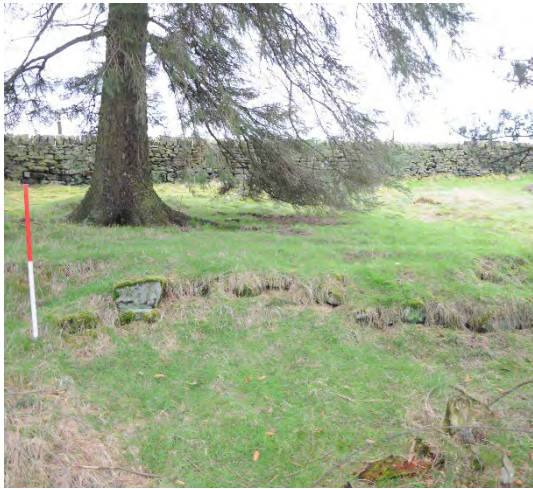
RUINS		BUILDING 8
Designation Non-designated

Primary Phasing Built between 1853 and 1893		
Description Potential remains of three structures (Appendix 2.17) within the northwest of the plot corresponding with the location of buildings marked on historic maps (Appendix 1.2). The top of linear stone-built walls are visible at points beneath the turf.

Construction works are likely to result in a **negative effect** on archaeological remains of local significance, although this harm could potentially be mitigated by preservation in situ of any internal structures. This effect can potentially be partially offset, to achieve a **limited negative effect**, by a suitable condition of planning consent for approval of foundation details to enable targeted preservation in situ of important remains and a watching brief during demolition/groundworks to secure preservation-by-record.

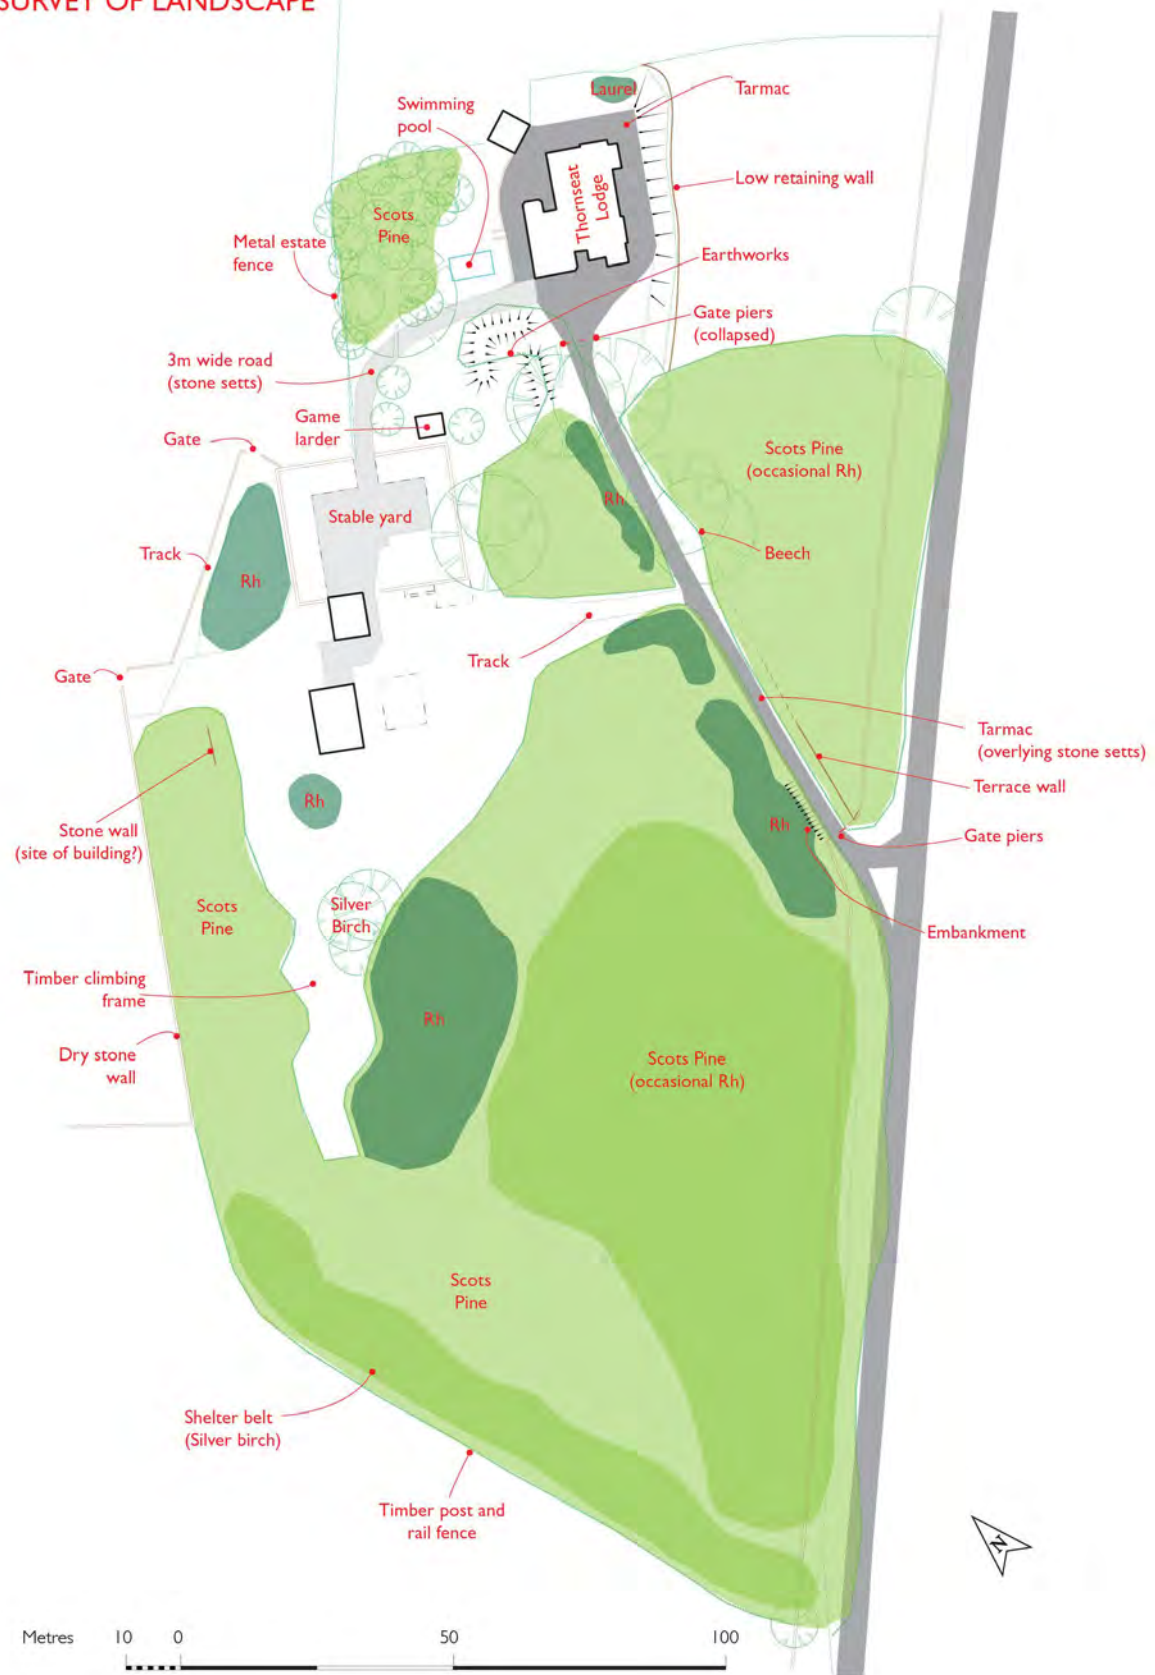
Figure 5: Survey of the landscape surrounding Thornseat Lodge (Rh = Rhododendron)

There always appears to have been an area of open ground in front of the lodge to the south-east, providing commanding views out into the valley, but also enabling passing traffic along Mortimer Road to see the principal façade (**Appendix 2.27**).

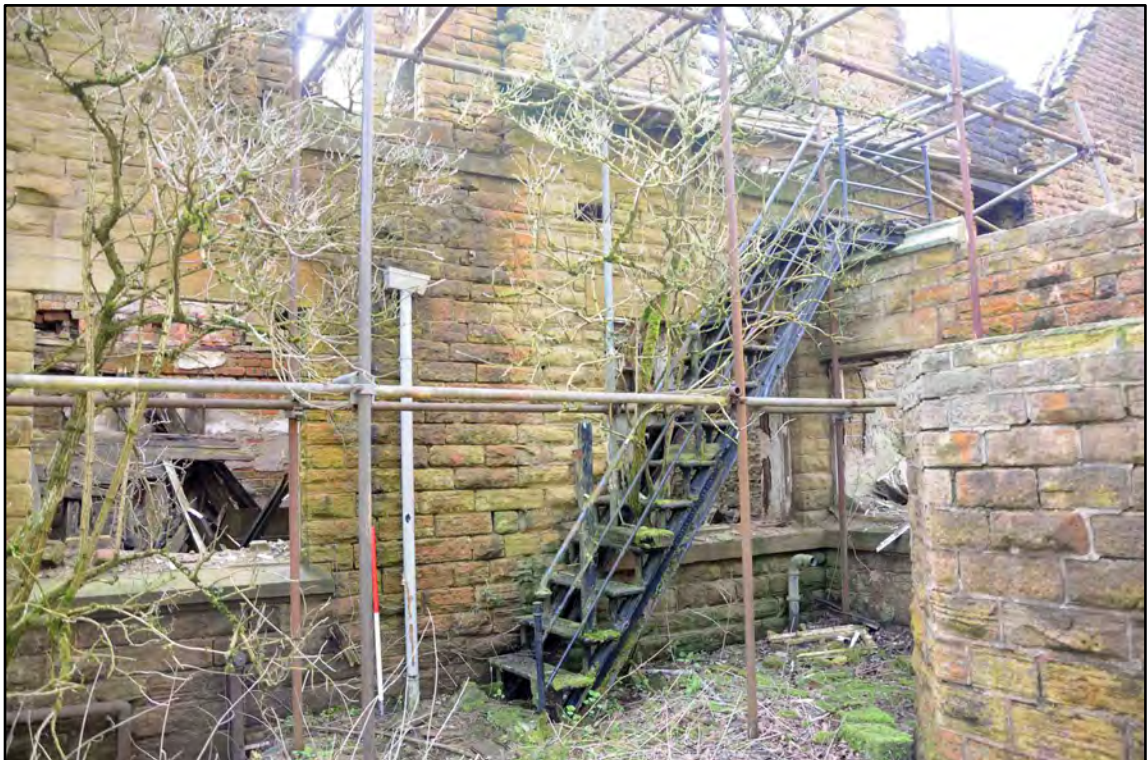
Appendix 2.10: Detail of cast-iron fire escape at rear of Thornseat Lodge (1m scale)

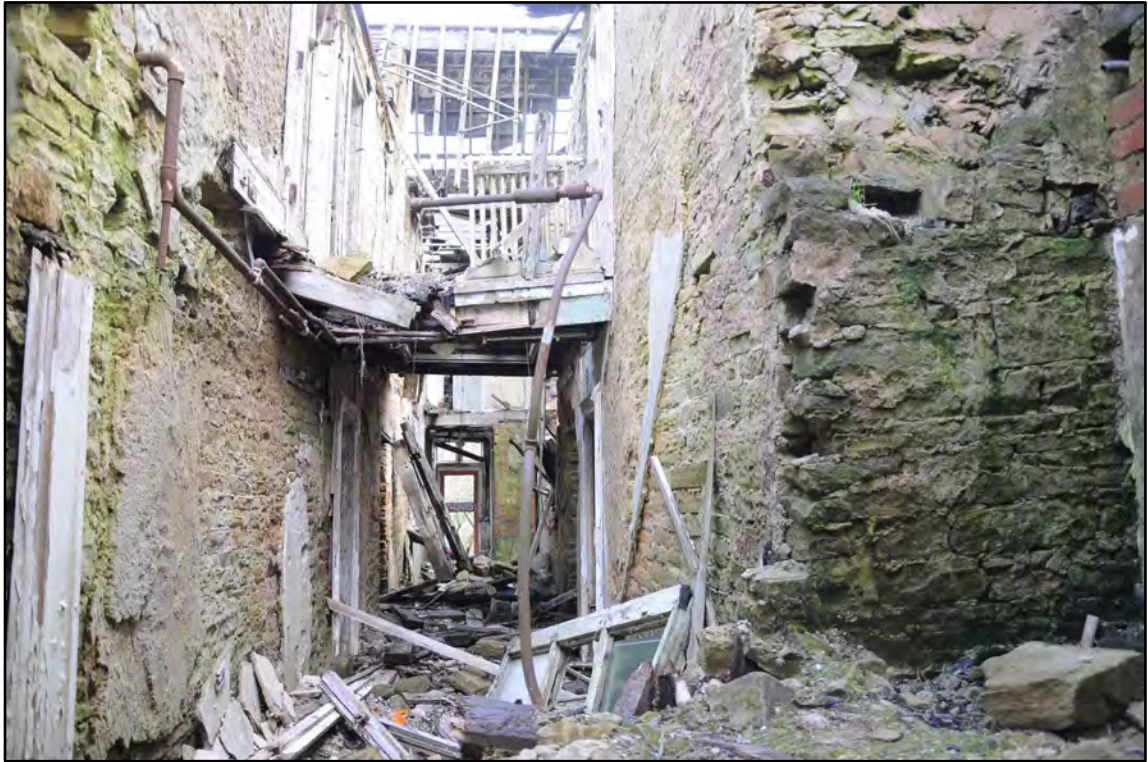
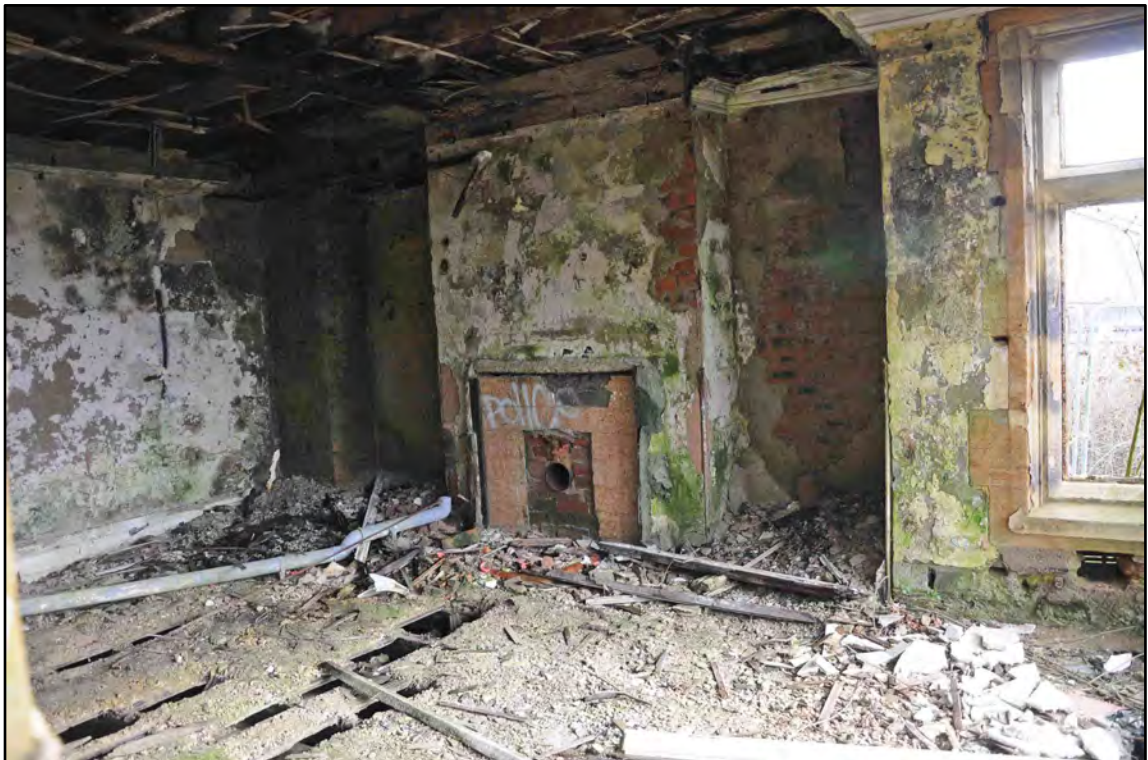
Internally the building has largely been gutted, although the position of walls and floors is legible (**Appendix 2.11-12**). The two principal phases of construction are reflected internally in the use of materials, with stone used for internal walls in Phase 1 and brick used in Phase 2. Some architectural detailing survives in places including areas of fragmentary plaster cornice (G1, G4 & G8), some internal door and window architraves, and an area of panelling in G7. No unaltered fireplaces were observed.

Appendix 2.12: General view into interior of Thornseat Lodge (No Access)

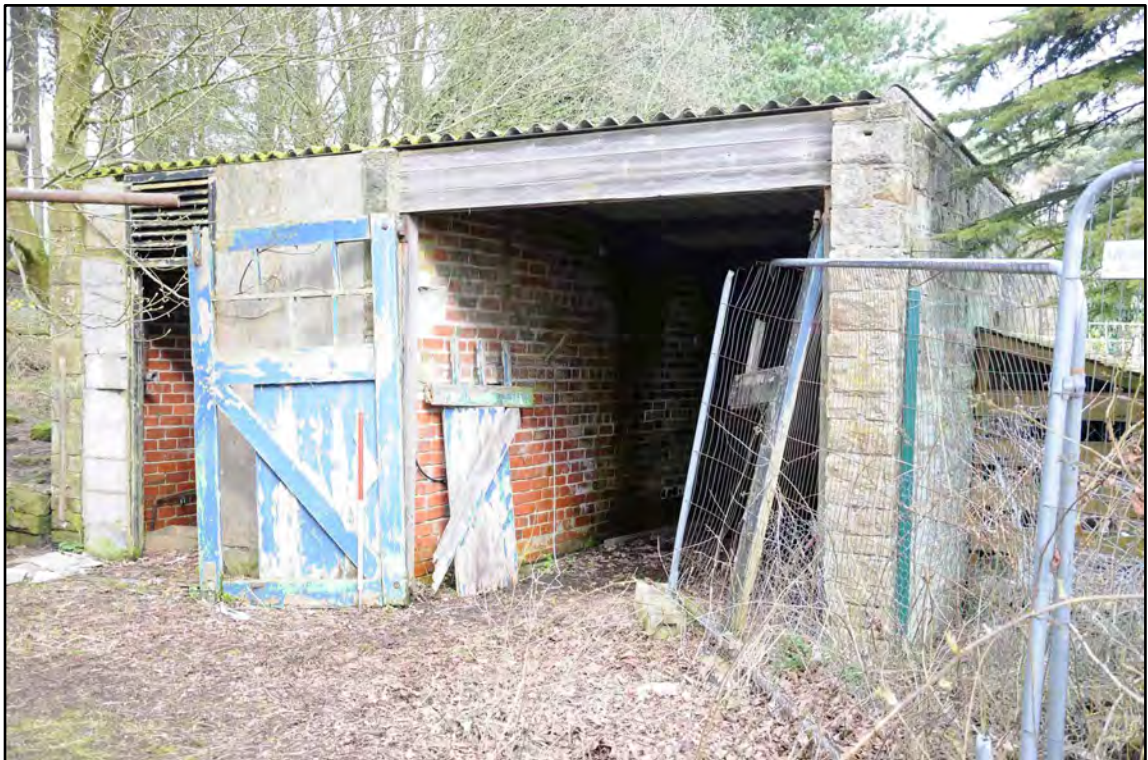
Appendix 2.14: General view of modern garage at rear of Thornseat Lodge (1m scale)

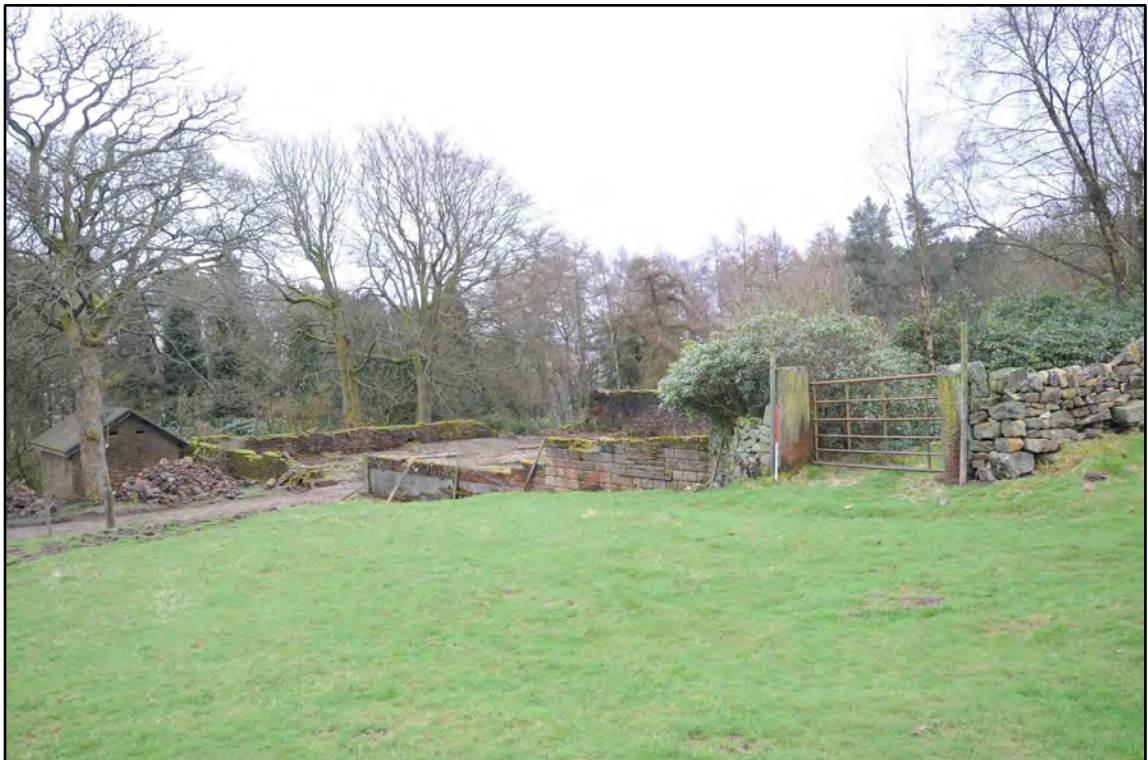
Appendix 2.18: View looking south towards former entrance into stable yard (1m scale)

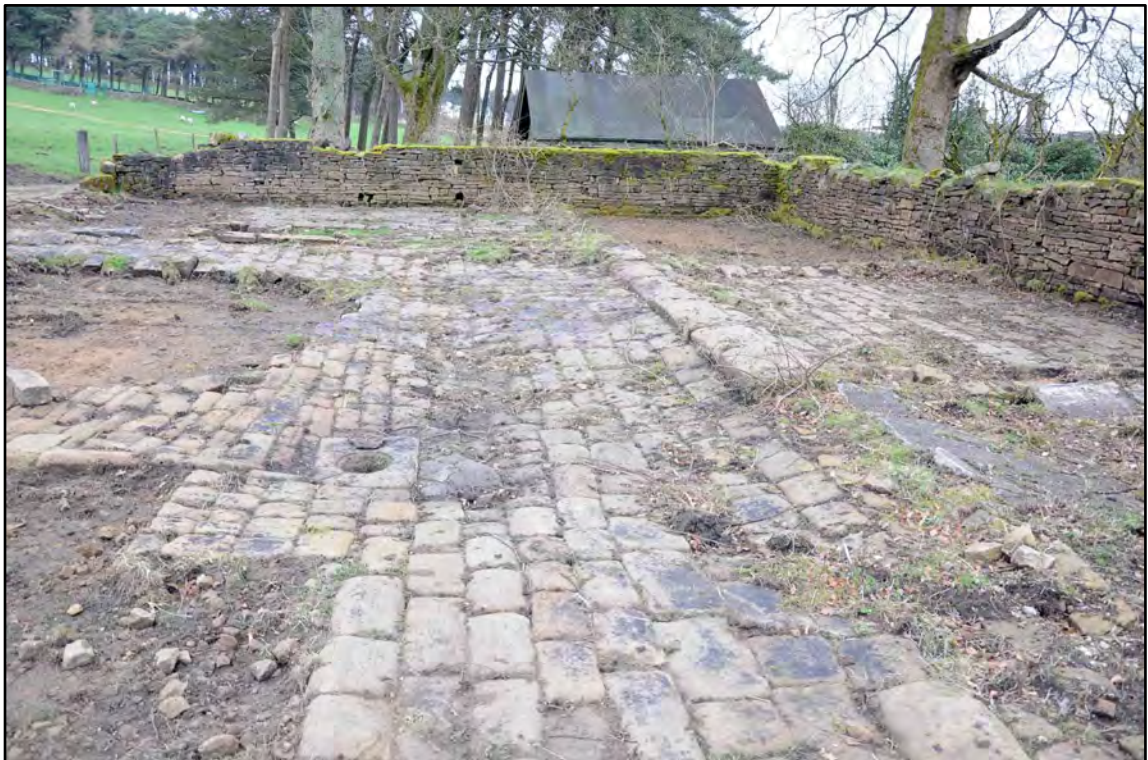
Appendix 2.20: Detail of stone setts in stable yard, looking north-east (1m scale)

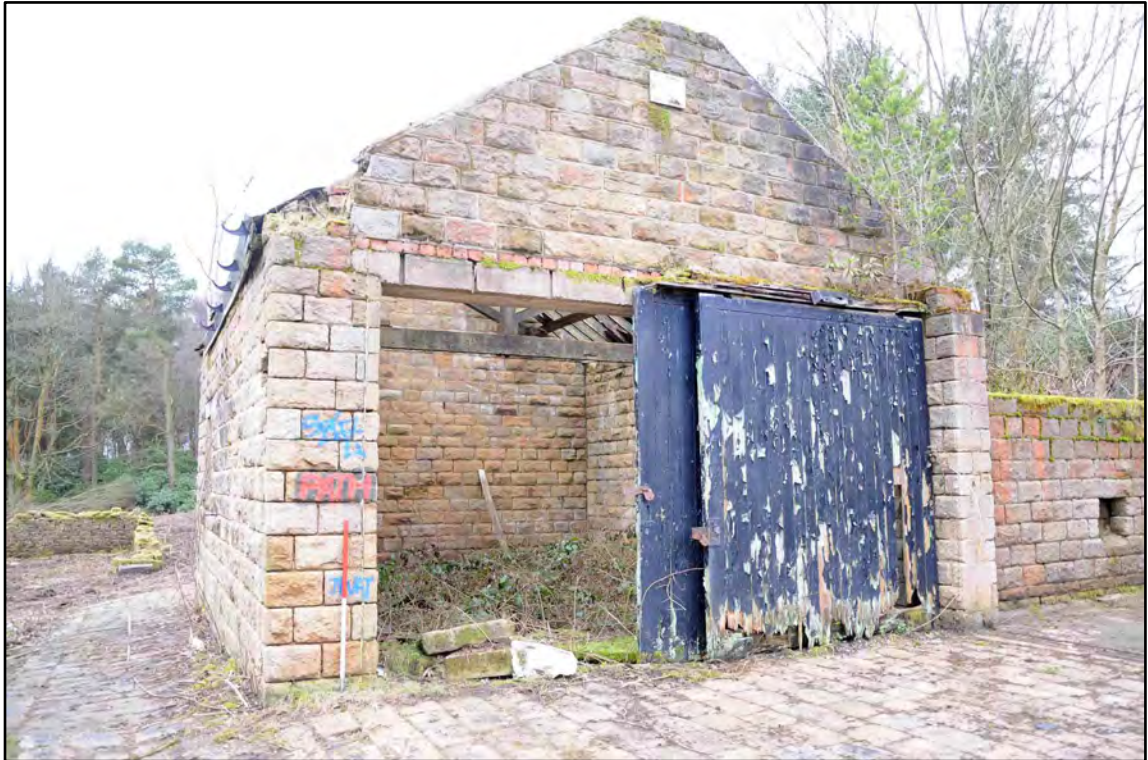
Appendix 2.21: Detail of exterior of former grain store (1m scale)

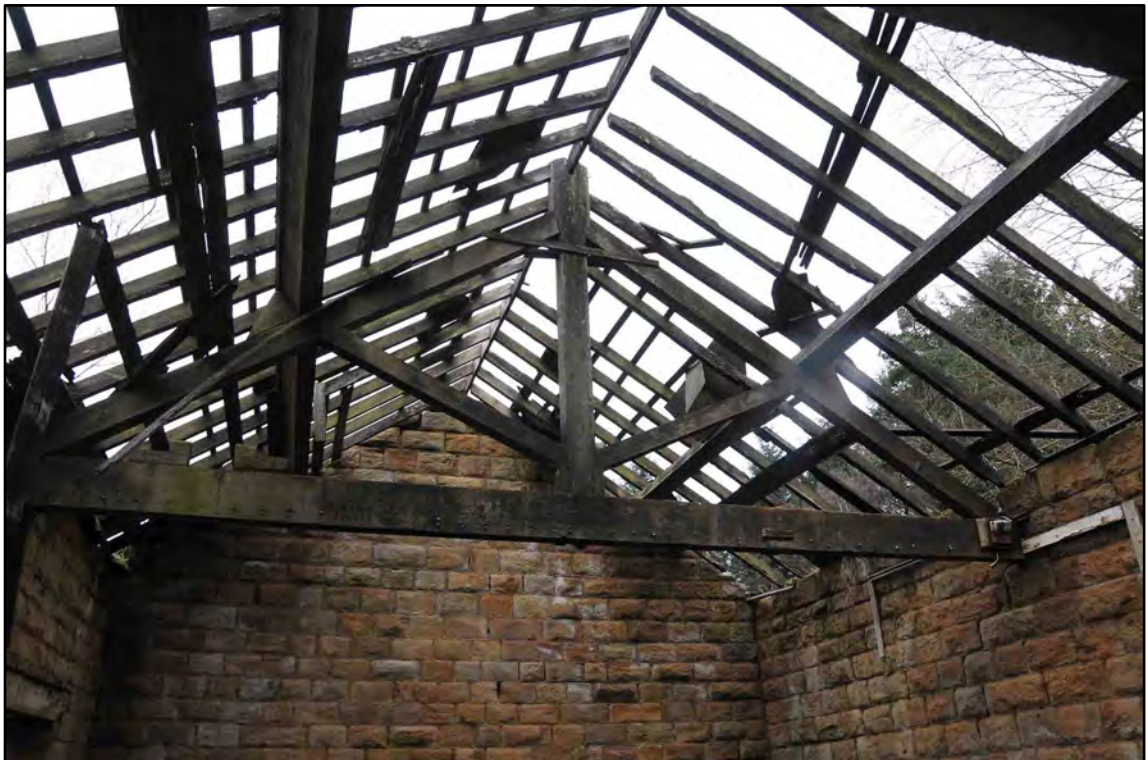
Appendix 2.22: Detail of interior of former grain store

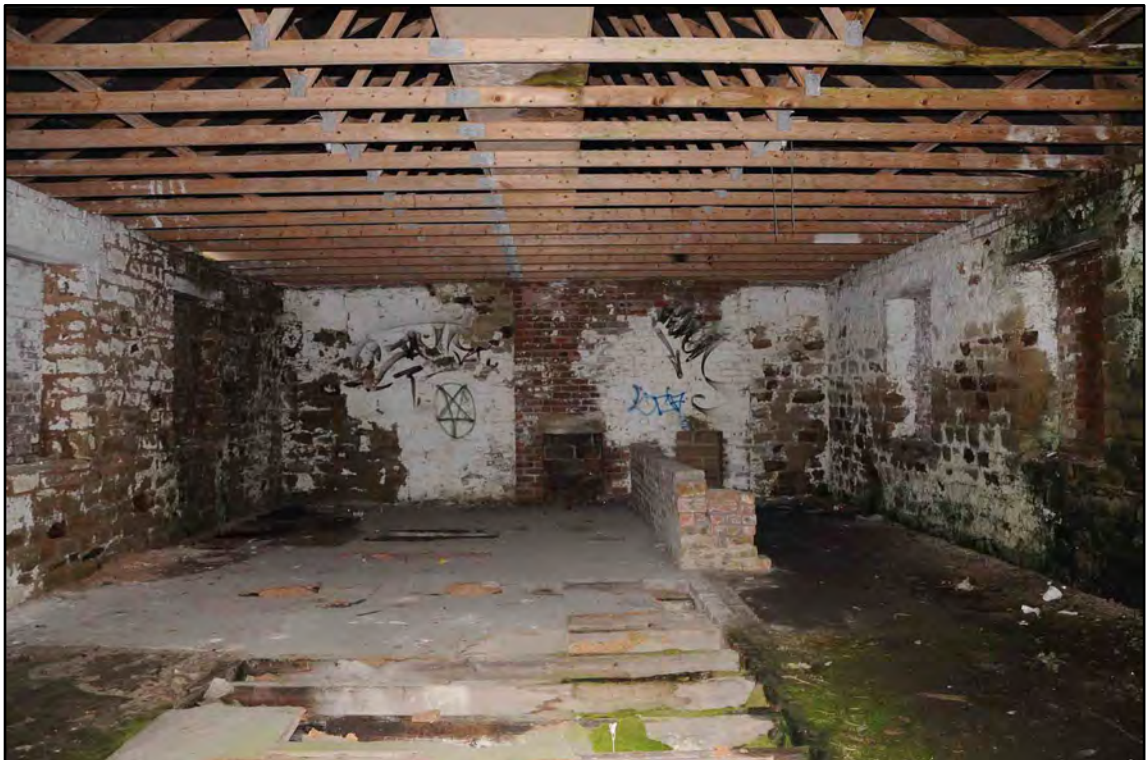
Appendix 2.24: Detail of interior of outbuilding; note replaced roof trusses

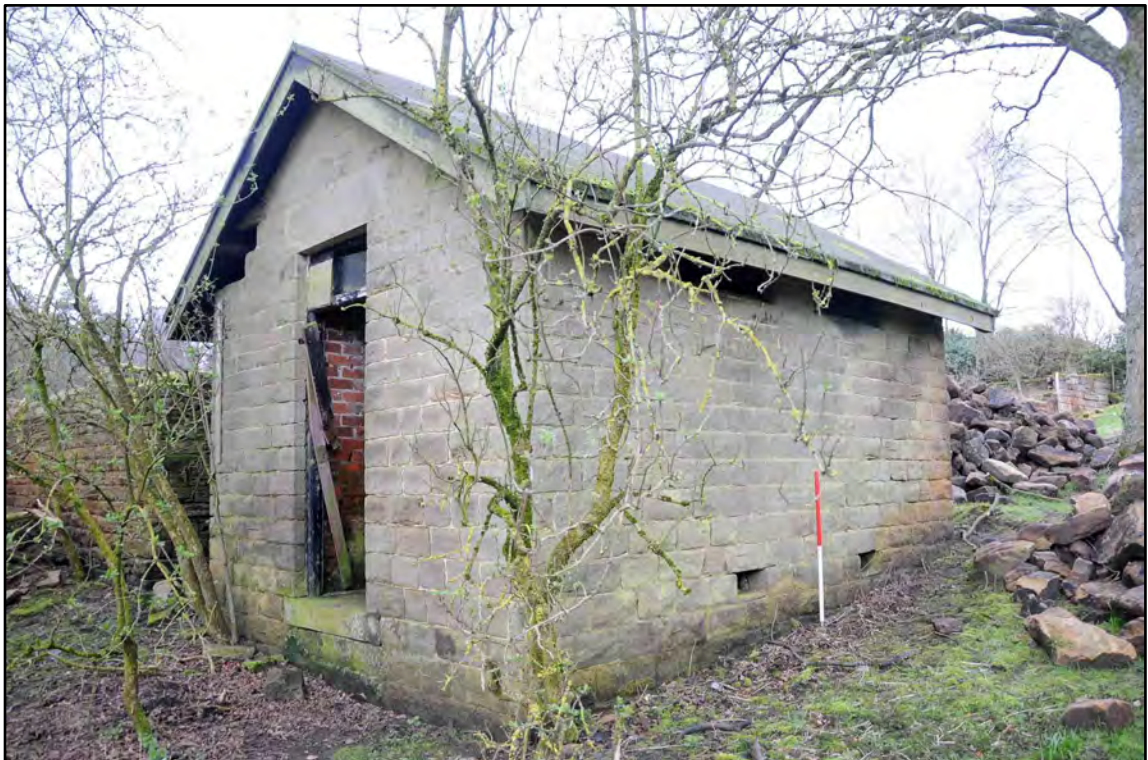
Appendix 2.26: Detail of former Game Larder with glazed tile interior (1m scale)

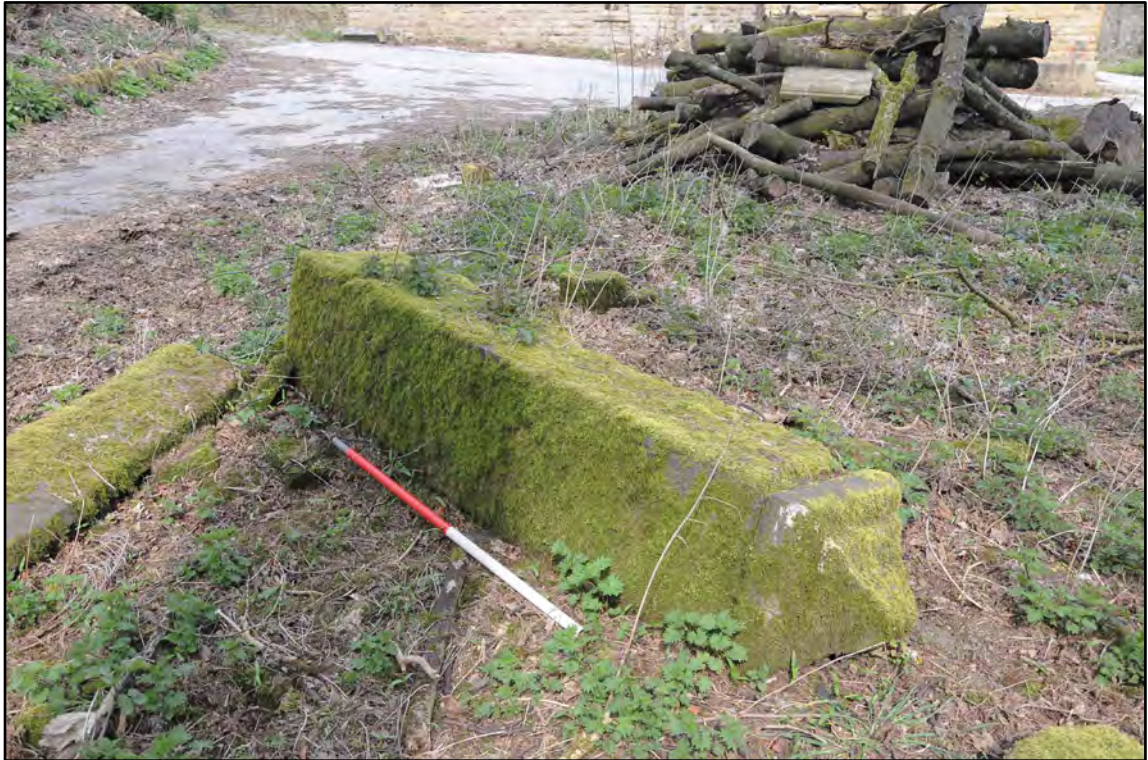
Appendix 2.31: Detail of fallen gate pier at northern end of drive (1m scale)
