# HAMMERTON HALL FARM, LITTON, DERBYSHIRE

## Significance & Heritage Impact Statement

**Hammerton Hall Farm, Litton, Derbyshire, SK17 8QP**

**Significance & Heritage Impact Statement**

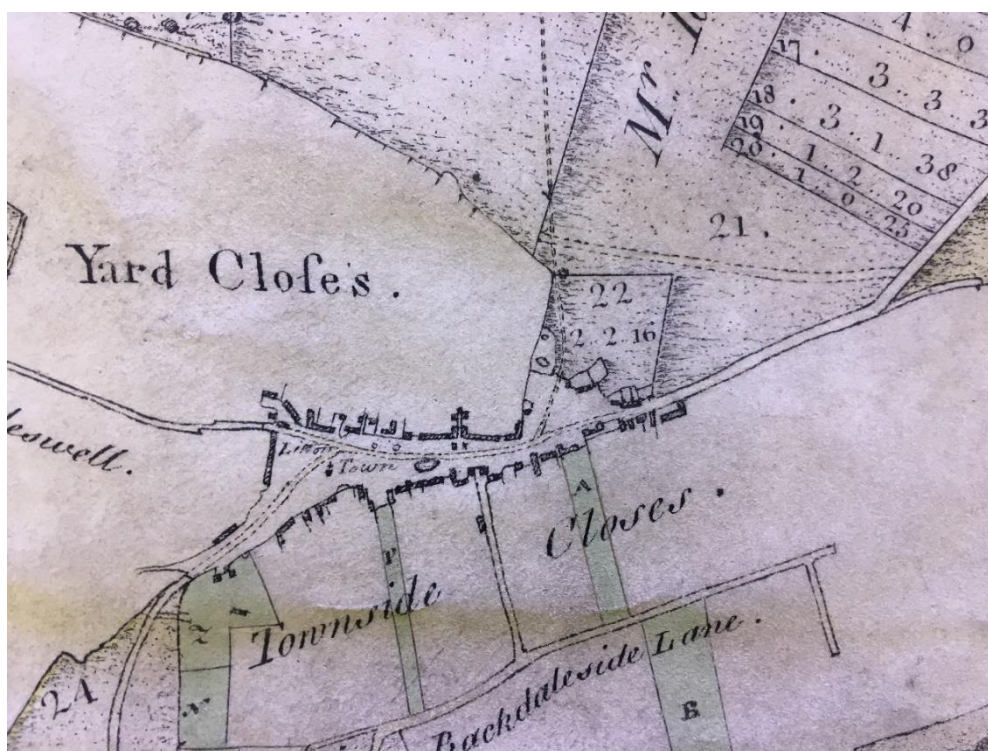
Fig.1: Litton village on the 1764 Enclosure map (Derbyshire Record Office Q/RI 67)

It is not known when Hammerton Hall Farm was first created as a farming unit; while the present house dates from the 1760s and the buildings are later, the site may have medieval origins, associated with strip fields on the edge of the village. The earliest map to show the village in any detail is the enclosure map, of c1764; the Enclosure Award for Litton was made in 1764 and there are two similar maps made around this date showing how the common land was allotted to the landowners. Some outbuildings on the site seem to be shown on the 1764 enclosure map, but not the present house; the architectural style of the house and the rainwater hoppers dated 1768 indicate that the farmhouse was built or rebuilt shortly after the enclosure award. The enclosure map seems to show outbuildings on the farmstead site, but as the map scale is small it is not certain what they were.

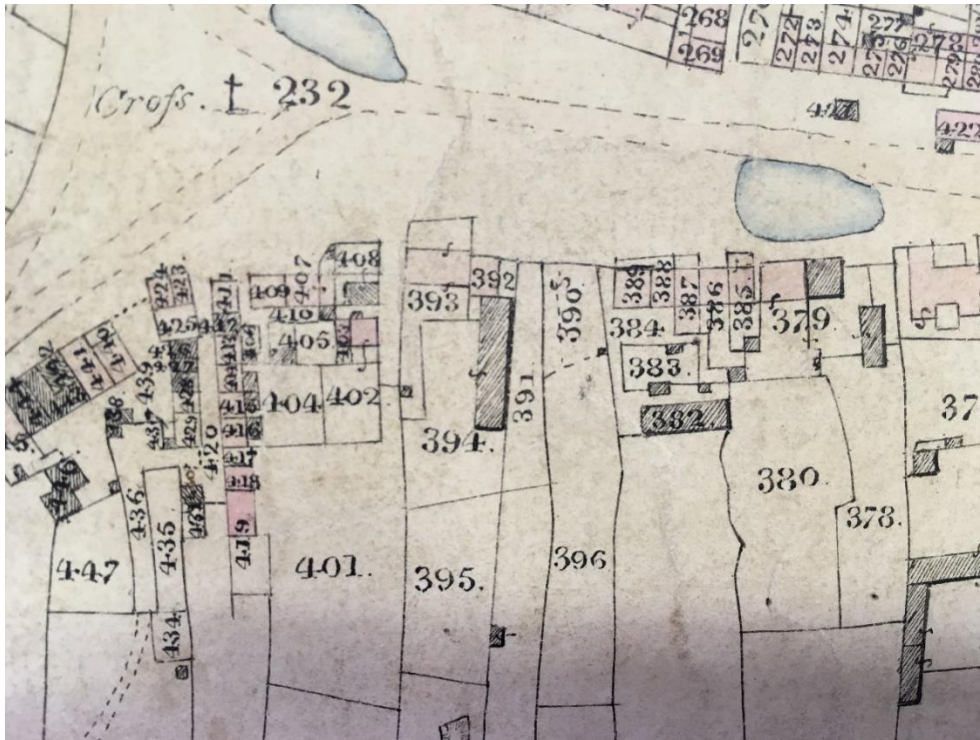
Fig.2: detail from 1847 tithe map (Derbyshire Record Office D1494 A/PI 337)

The first map to clearly show the existing farmhouse and farm buildings is the tithe map dated 1847; this shows the whole of the linear farm building to the south-east of the house but not the detached building to the south. By this date, all of the farm was part of the Curzon Estate (Earl Scarsdale) who owned it until the sale in 1918. In 1847 the occupant of the farm's 'outbuildings and stack yard' (394 on the map), 'lesser yard' (395) and 'farmyard' to the east (391) was John Baker, but the farm house and garden (393) were tenanted by Hannah Newton and the east part of the house (392) was separately occupied by Mary Penman. It is not known why the domestic and farm buildings were in separate tenancies at this date; it may have been because John Baker had another house or perhaps Hannah Newton was a farmer's widow and not able to manage the farm.

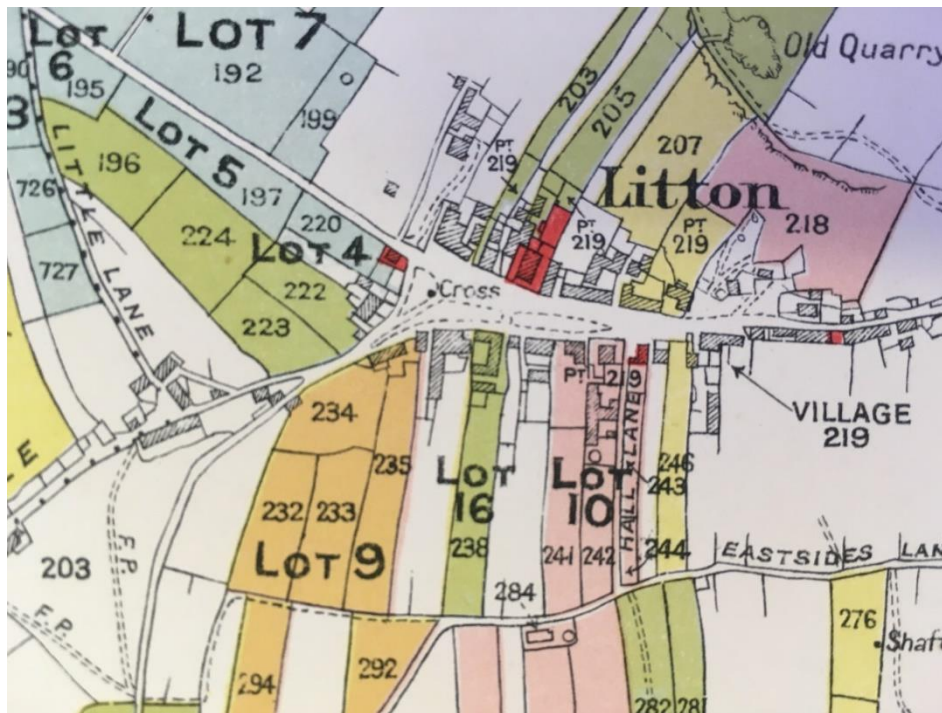
*Fig.4: 1918 sale plan (Derbyshire Record Office)*

In the 1918 description of the holding the linear farm building is described as a 'range comprising cowhouse for 5, fodder house, cowhouse for 5, stable for 2 with loft over, 2 hay barns, 2 pigsties'. This description seems to list the separate bays or building elements from north to south, making it possible to identify the separate uses for each bay at the time of the sale. Also listed were 'another range comprising cowhouse for 5, cowhouse for 9, closed cart shed, open cart shed, a stirk shed with tying for 24'. The term 'tying for' refers to the number of cows that a shippon could house in stalls. A 'stirk shed' is a building for heifers or bullocks.

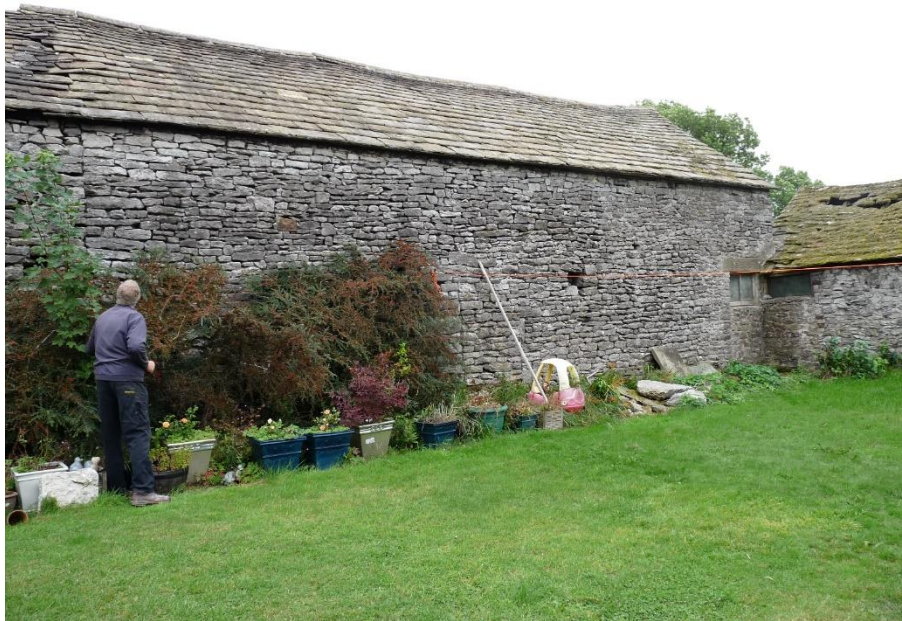
*Fig.6: west elevation of south part of linear range, with straight joint visible to left*

The linear 2-storey main range is of two main construction phases, divided by a straight joint in the masonry (visible on the west elevation); the northern half is the earlier. The whole range is shown on the 1847 tithe map; although it is not possible to firmly date the two elements as there are no easily dateable features, the general character of the building suggests that both parts were built in the early 19<sup>th</sup> century. Cow houses are rare before the early 19<sup>th</sup> century, which saw a great increase in cattle raising and improvements in husbandry.

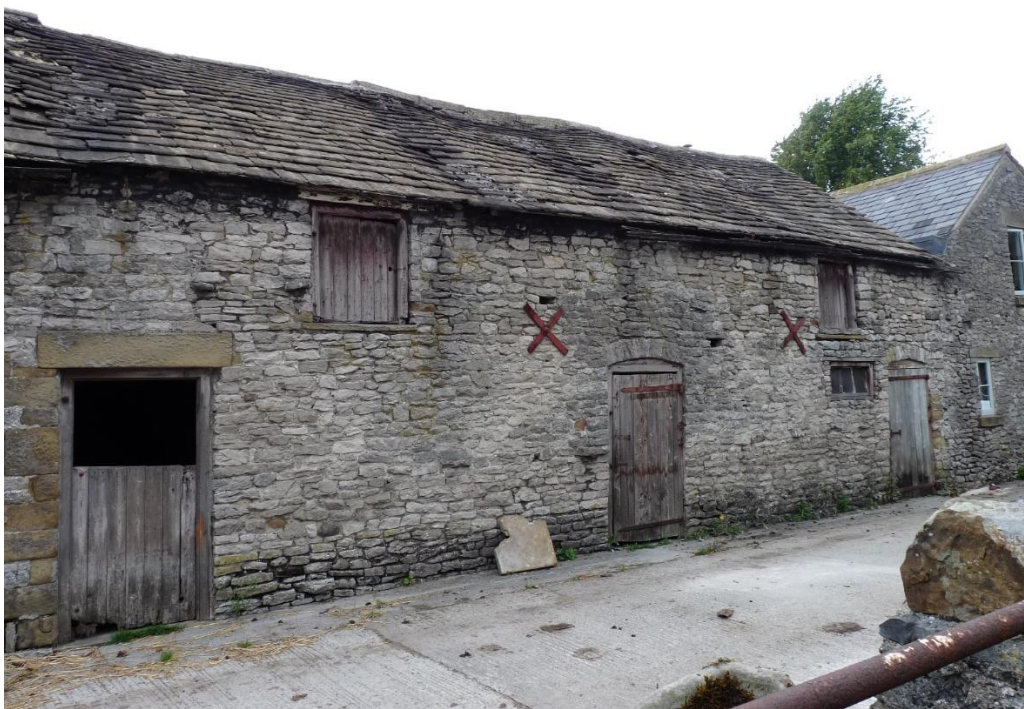
*Fig.8: cowhouse in north part of the range, from the east, with central passage doorway*

The north part of the range is a type of cow house known as a 'cross shippon' as the stalls for each part of the cow house face a cross passage (Barnwell and Giles, 1997, p134). This results in this part of the east elevation being almost symmetrical, with a central passage door flanked by two doorways to the cow houses and on the first floor, two loft openings. The inserted hopper window to the north cow house is later. The two doorways to the north have segmental heads, but the south doorway has a stone lintel which is probably a replacement as there are signs the wall above has been rebuilt. The two north doors open outwards and are of plain boarded timber with strap hinges; the south of the three is a stable door. The first floor has two matching openings serving the lofts over the cow houses, each with an inward opening timber shutter in a plain frame. This wall has visible structural defects; the wall leans out towards eaves and there is an apparent lack of bonding between the front wall and inner cross walls. Iron ties have been used to reinforce the walls.

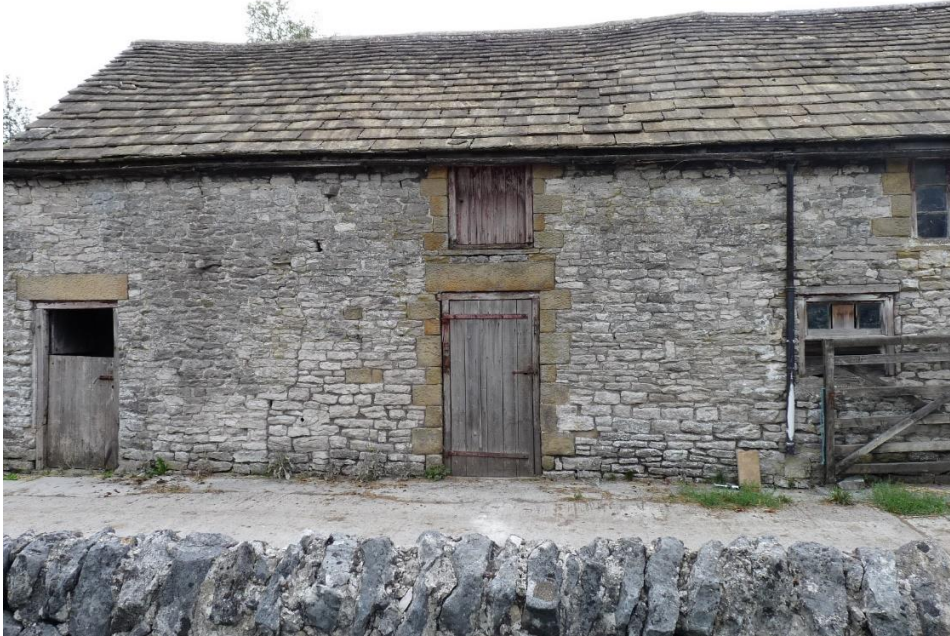
*Fig.9: south part of linear range, from east*

A clear straight joint on the west wall separates the masonry of the north cow house from the south part, but the joint is less visible on the front east wall. The south part of the range also has a rough joint in the masonry towards the south end of the east wall which may indicate the south bay was added as a third phase, but as this is not evident on the rear (west) wall it may relate to a repair (Fig.9). The south bay has one inward-opening stable door with stone lintel. The next bay north has a doorway and shuttered loft opening, directly aligned, both with neat sandstone quoins. The boarded door open outwards, with strap hinges and the plain

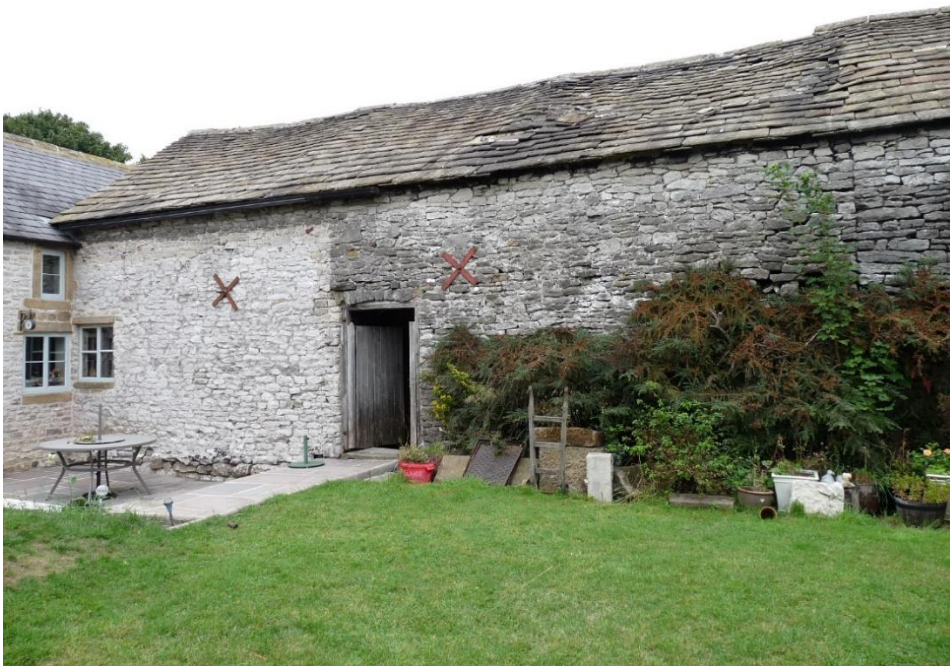
*Fig.10: rear of north cowhouse, from the west with central doorway to passage*

The north part of the west elevation had a small window towards the north end, which relates to the northern shippon. The wall area between the doorway and this window is pale as a former dairy was removed here.

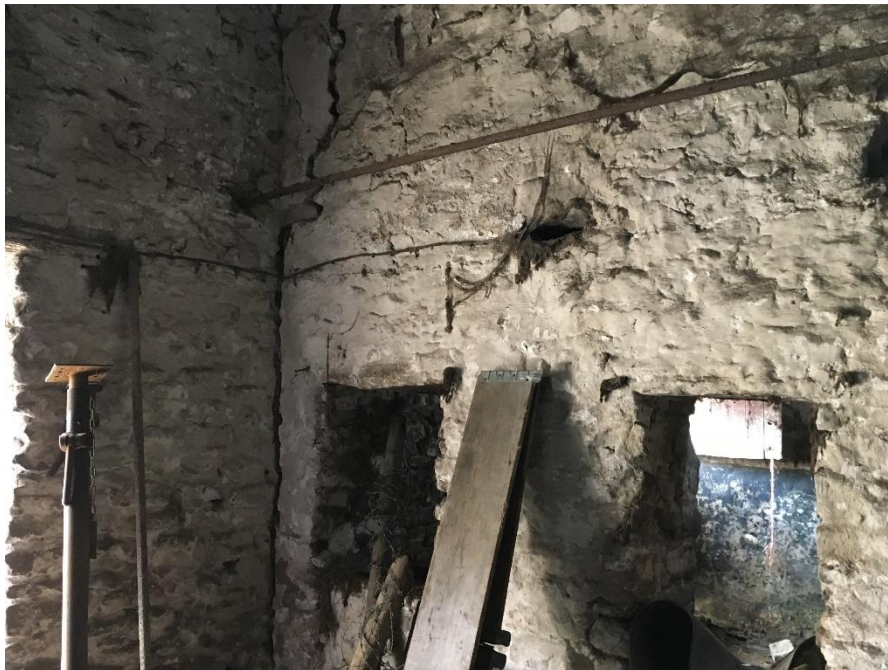
*Fig.11: south side wall to passage, with feed openings and tie-rod, from the NW*

The interior layout of the north part of the range is still legible although there have been alterations. The 3-bay range was built as a cowhouse for a total of 10 cows, which were housed in two cow houses, each originally with timber boskins that faced towards the wide central through passage. This feed passage has five narrow rectangular openings to each side wall which provided direct access to feed troughs or racks. The 1918 sale catalogue refers to this area as a 'fodder store'. The walls are white-washed and the floor is laid with rough stone flags. The space is open to the roof; in the walls above the feed openings are high level doorways to access the lofts above the cow houses.

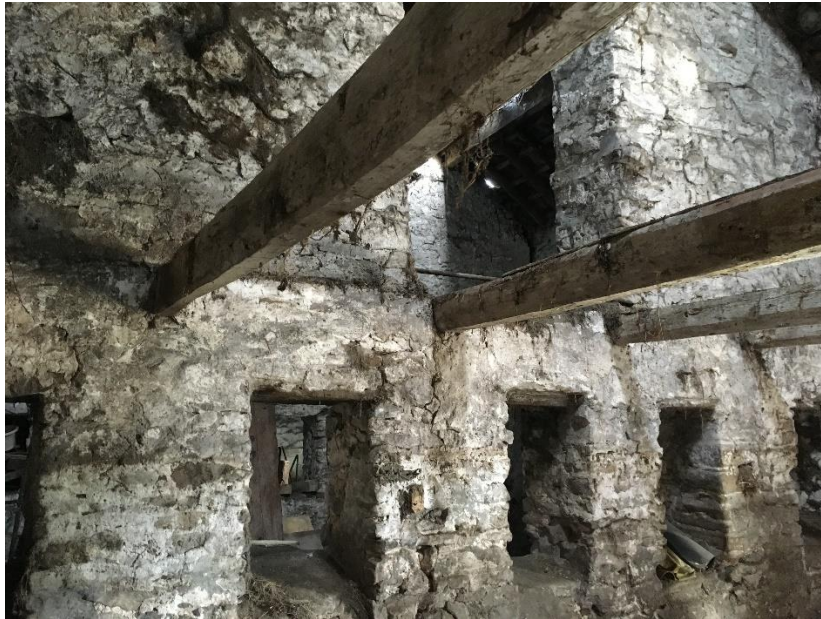
*Fig.12: feed holes and loft floor joists in the south cow house, from the SW.*

The north cow house retains some timber boskins, probably replacements for the originals, but none survive in the south cow house. The floors are concrete, laid in the 20<sup>th</sup> century, with a stone kerb or heel to the raised area of the stalls or bosses/boosts. The loft floor joists appear to be pine and in poor condition, the walls, joists and the underside of floor boards are white-washed.

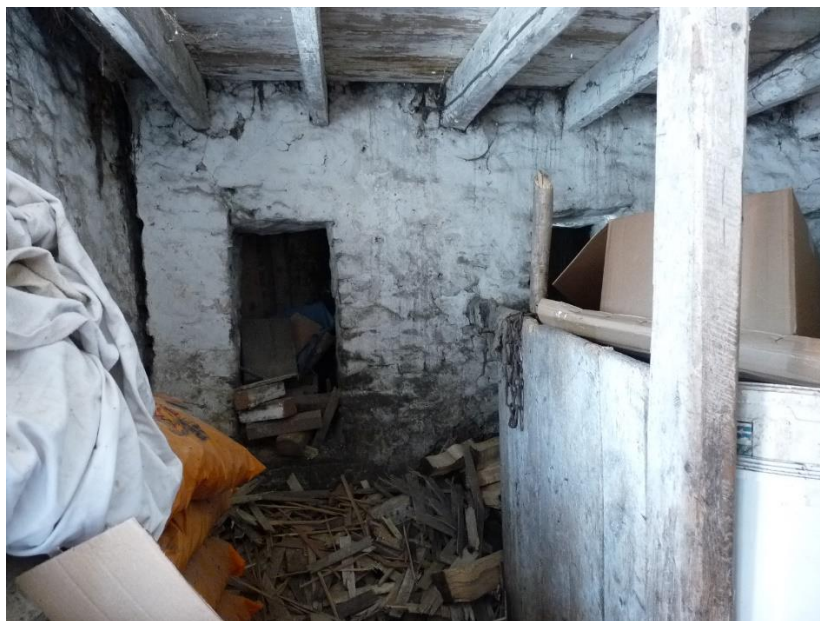
*Fig.13: north cow house with timber boskins and feed holes, from the north*

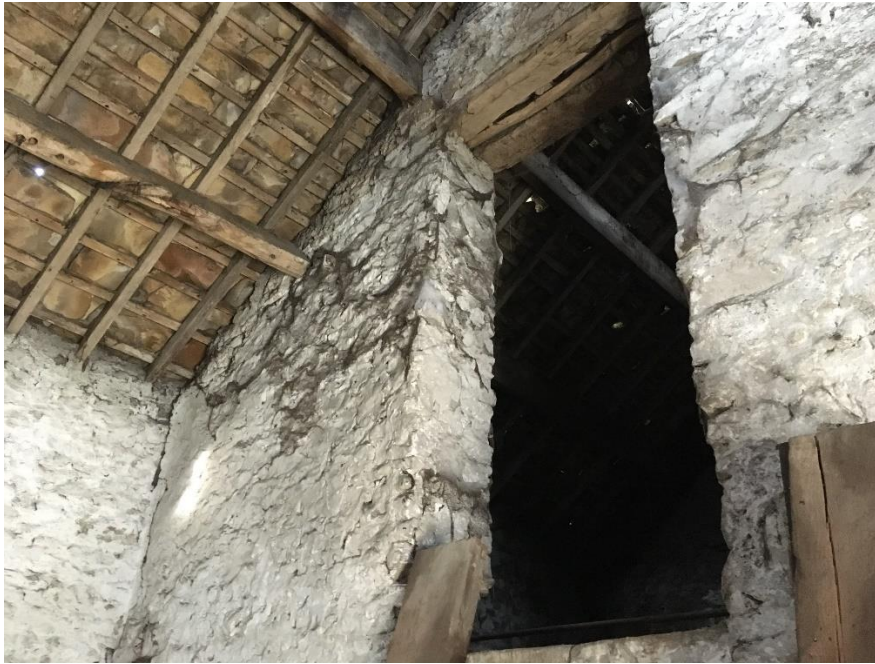
*Fig.14: roof to through passage, and access doorway to the north loft from the passage*

The lofts over the north and shippons have not been assessed in detail as the floors are unsafe or missing, but the purlin roof structure is visible from below (Fig.14). There are tall doorways into the lofts over the shippons from the through passage (Fig.14), as well as shuttered pitching holes on the east elevation for loading hay and other fodder. The roof of the north part of the range has no trusses as the purlins are carried on the full-height cross walls. The rafters and purlins are mainly pine with some hardwood. The roof is in very poor condition, with slipped slates and failed battens.

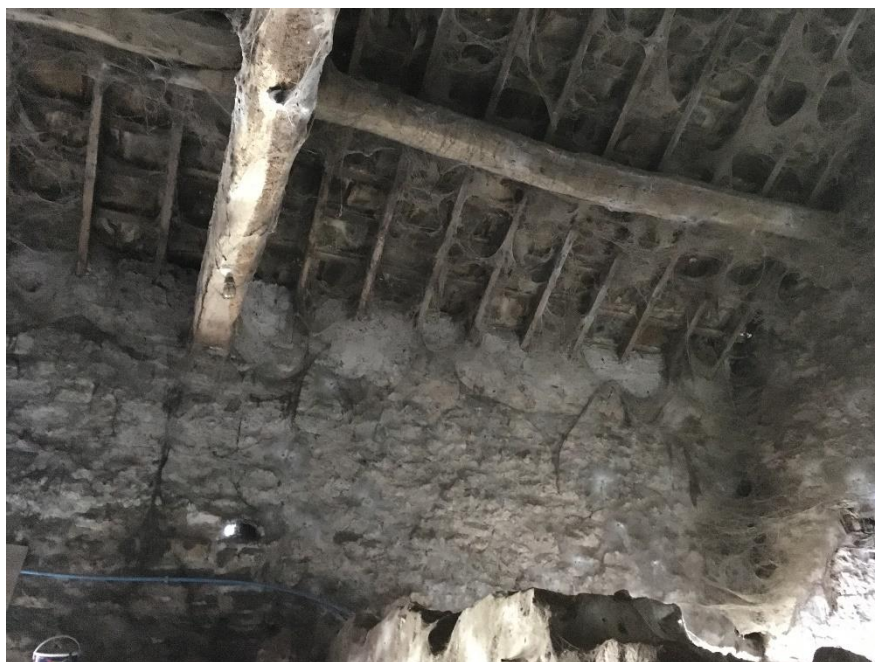
*Fig.15: south bays with partial cross wall and roof truss, from the east*

The 3-bay south part of the main range is divided into a 2-bay former hay barn at the south end which is open to the roof. There is one hardwood tie-beam truss with a high collar and short raking struts carrying the purlins, which are mixture of hardwood and later pine. Rafters to the west pitch are mainly pine with some hardwood to the east. There is a blocked first floor doorway in the cross wall to the north, and walls are white-washed. The bays are divided at ground floor level by a rubble wall that may have supported a partial loft in the past. The block-work corn bin in the north-west corner is modern.

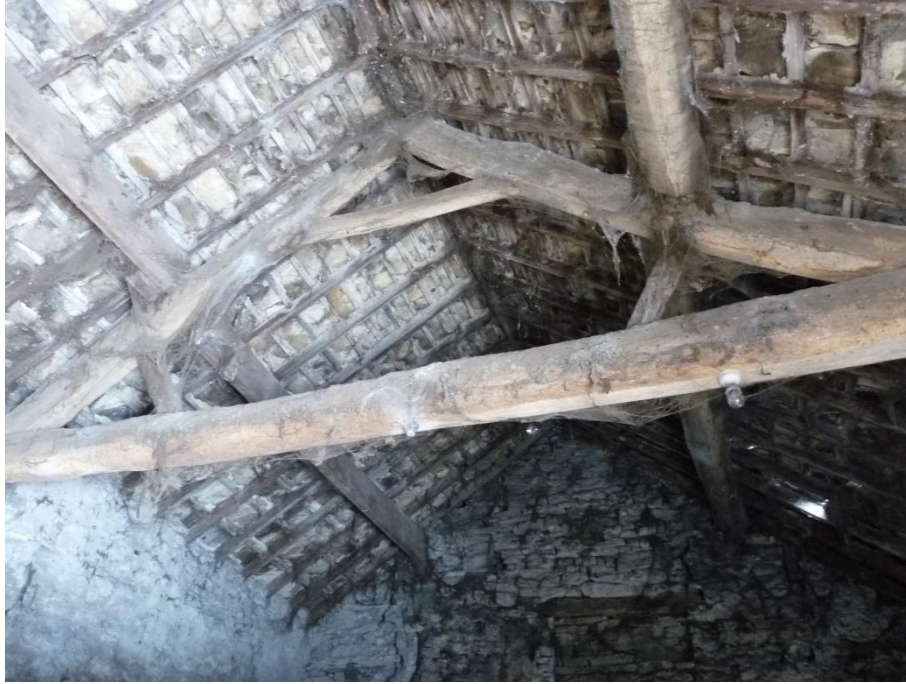
*Fig. 16: roof truss in two south bays, from the north.*

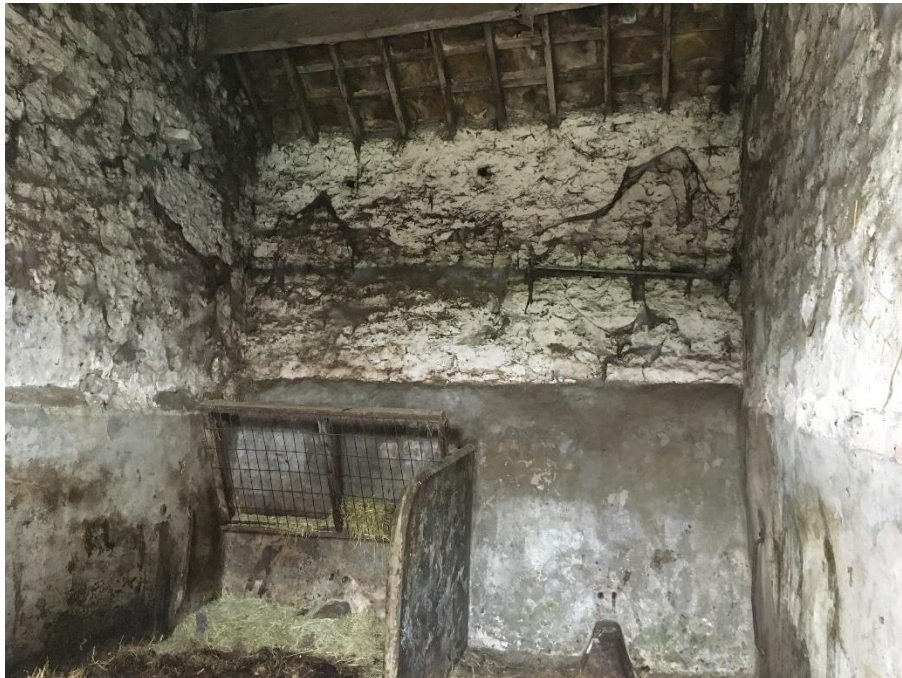
*Fig.17: cow house in third bay from the south*

The third bay from the south was formerly used as a stable (according to the 1918 sale particulars), but no stable fittings remain. This bay is defined by full-height cross walls, which support the purlins, and the walls are white-washed. The presence of a pitching hole opening on the east elevation suggests there was a loft floor, but this is missing. The space was re-fitted as a cow house for four beasts in the 20<sup>th</sup> century with cement part-way up the walls, ceramic feed troughs and a concrete stall partition against the west wall.

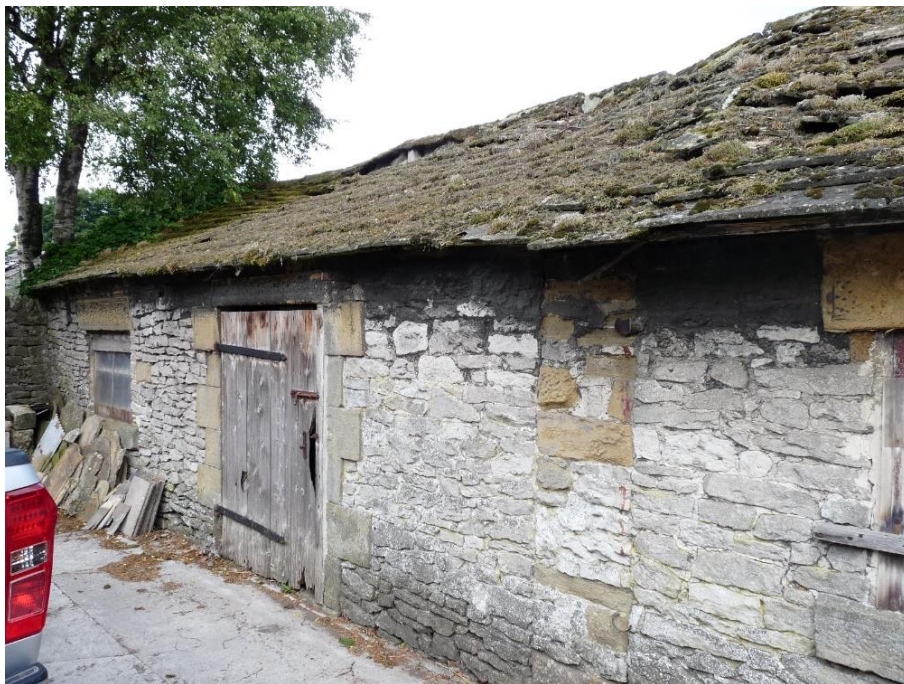
*Fig.18: south cow house, from the south-east*

The main south elevation has two similar doorways with boarded doors, dressed stone quoins to the jambs and two windows with stone heads and sills. There are two windows of different proportions on the north wall, each with 'hit and miss' vents, and a blocked doorway towards the east end of the wall.

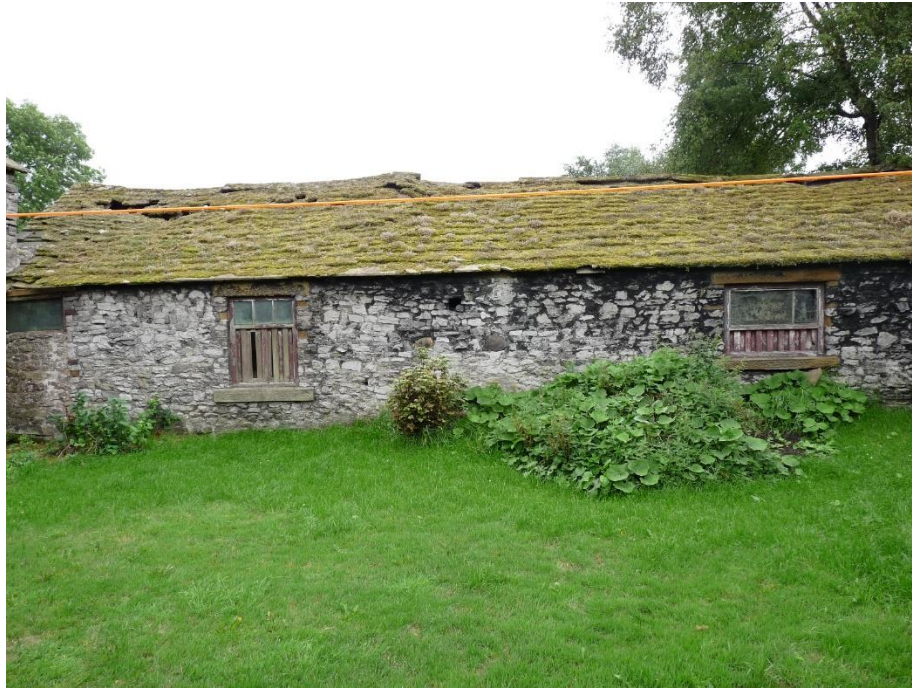
*Fig.19: cow house, north elevation from the garden*

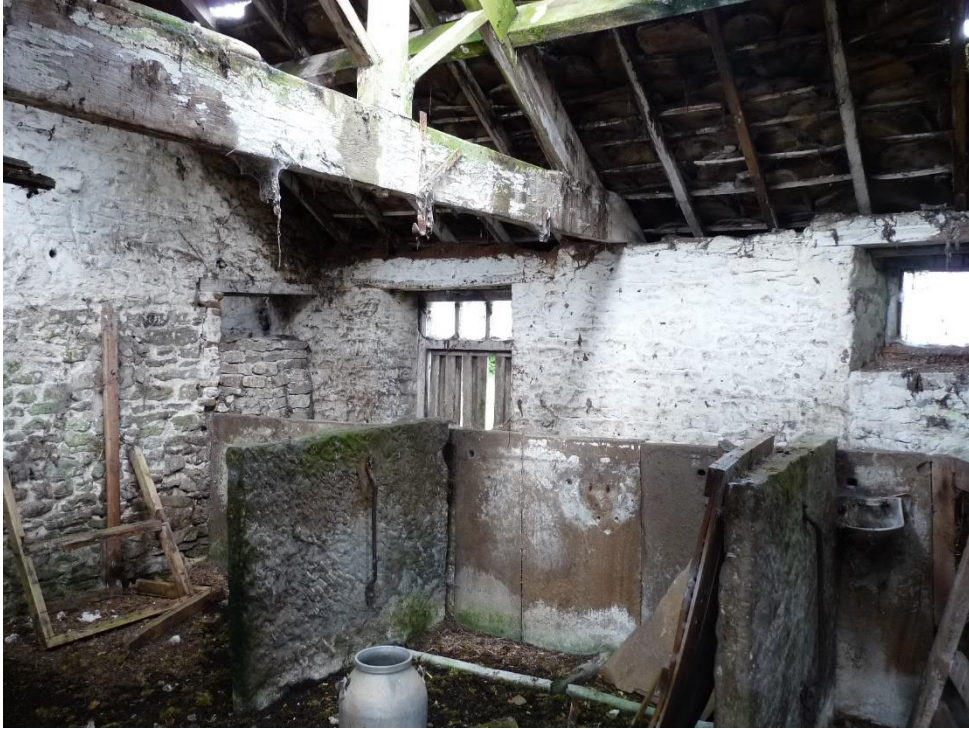
*Fig.20: interior of east cow house from the south-east*

The building is divided into two unequal spaces by a cross wall, with a blocked doorway at the north end of the cross wall. Each space has a pine king post truss carrying purlins, which have been reinforced with inserted part-trusses in the west bay (Fig.21); originally there would have been just one king post truss in the west bay. The smaller east part of the building has stalls for 5 cows facing north with stone slab boskins, partly built of re-used paving slabs (they are rough on one side), with an east-west feed passage along the north side. The larger west half has been altered and no stalls remain. The roof is in very poor condition and the building is not safe to enter.

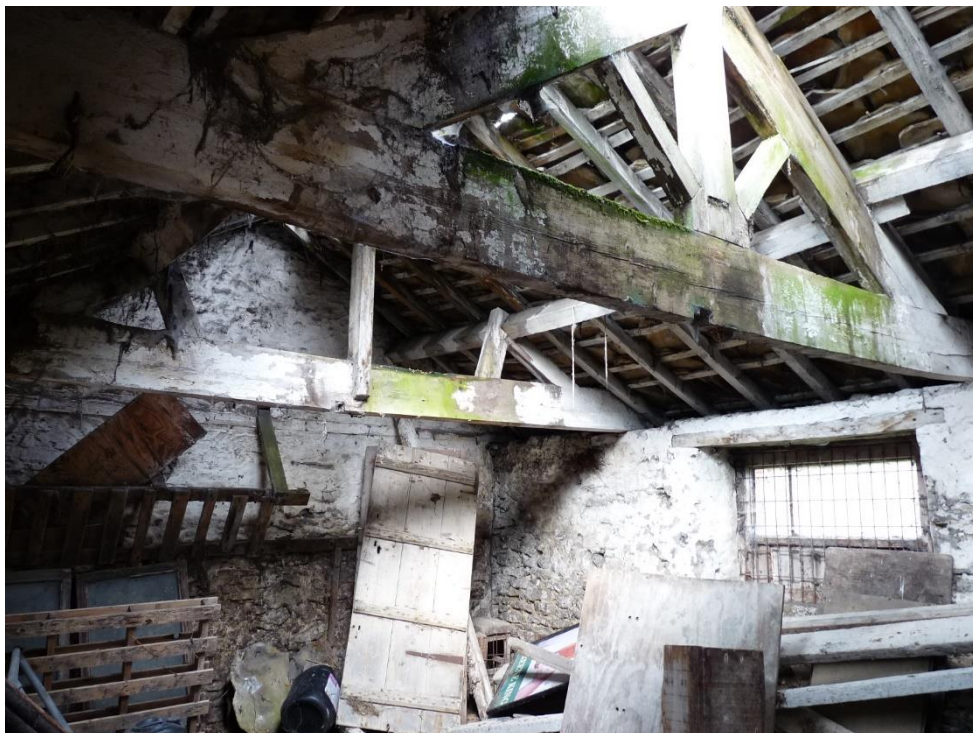
*Fig.21: west cow house interior from the south-east, with inserted partial truss to left*

In the south-west cow house, the roof is structurally defective and it is proposed to insert a steel ridge to reinforce the roof, retaining primary truss and purlins, but removing the later additional trusses (see Fig.21).

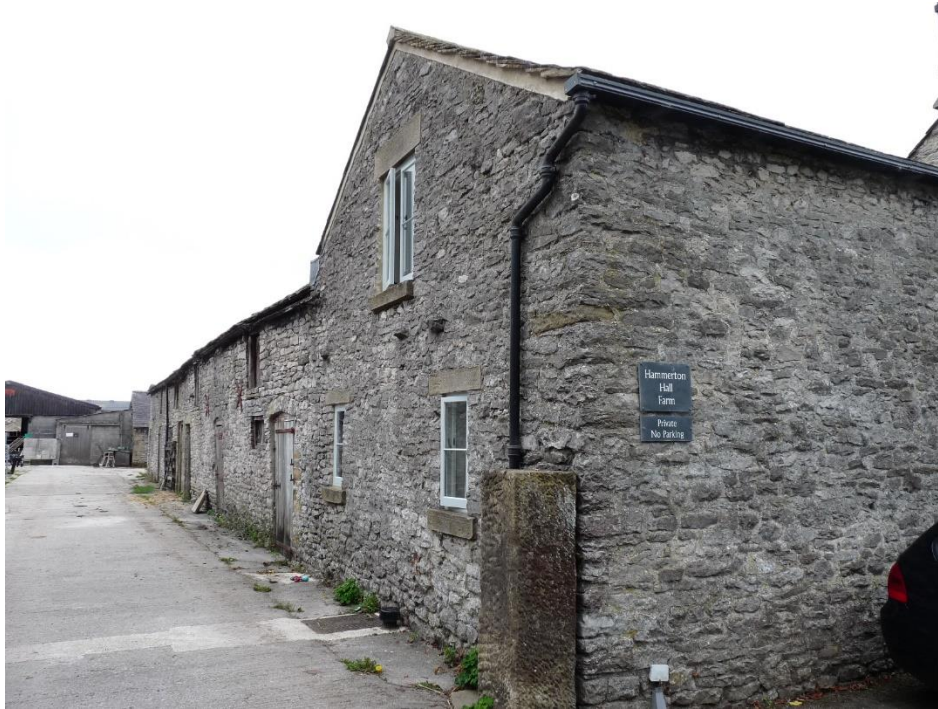
*Fig.23: view of farm buildings and yard, from the north*

The farm buildings are an important part of the setting of the Grade II listed farm house; they are important in visual terms and in enabling an understanding of the history and function of the house. The farm yards are hard-surfaced in concrete (Fig.23).

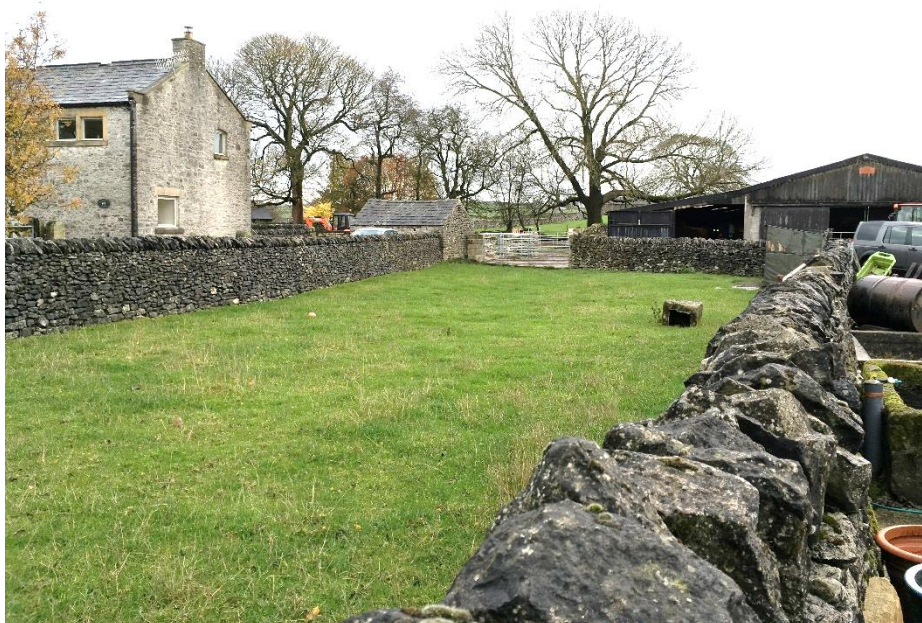
To the east of the linear range is a linear yard/access enclosed to the east by a rectangular walled close or paddock. The close is under grass, enclosed by drystone walls and has gated access to the south and west sides.

*Fig.24: close on east side of yard, from the north-west*

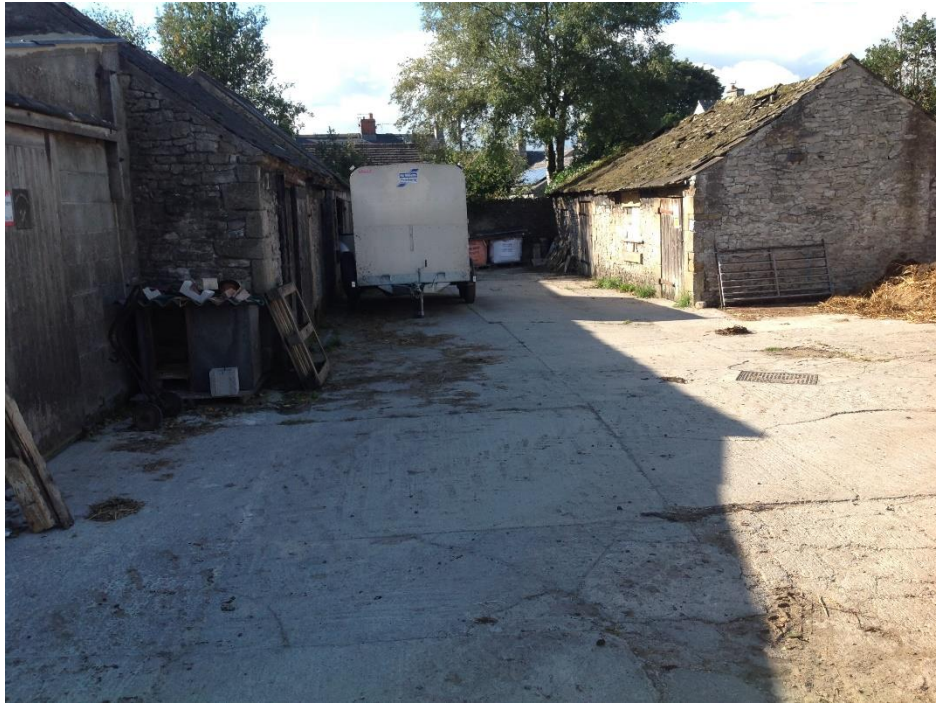
*Fig.25: concrete yard to south-west of farmstead with a late C19 cow house and 1970 dairy to the left and small cow house to the right, from the east (photo: Robert Hall).*

To the south of the single-storey south-west cow house, and facing it across a small yard, is a larger stone-built single-storey cow house. Like the former building it dates from the second half of the 19<sup>th</sup> century (Fig.25). Against the east gable end of the larger single-storey cow house is a former dairy of c1970, built of concrete blocks with a lean-to roof.

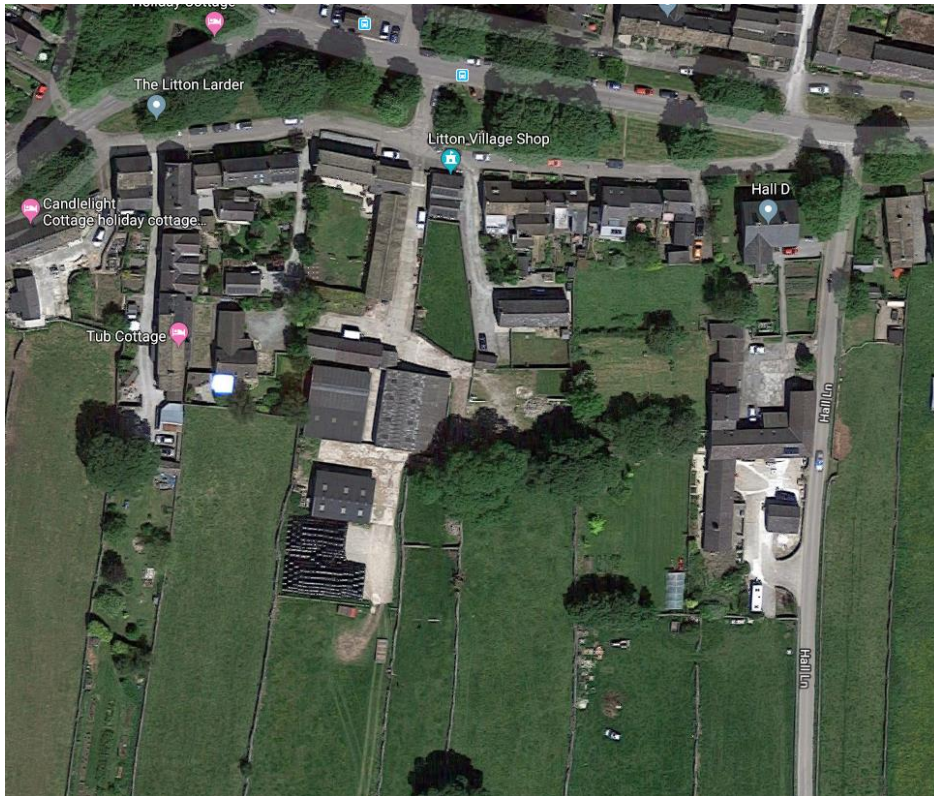
*Fig.26: aerial view (Google Maps)*

South and south-east of this is a group of three large portal frame farm buildings, representing the late 20<sup>th</sup> century and early 21<sup>st</sup> century expansion of the farmstead (see Figs.26 and 27).

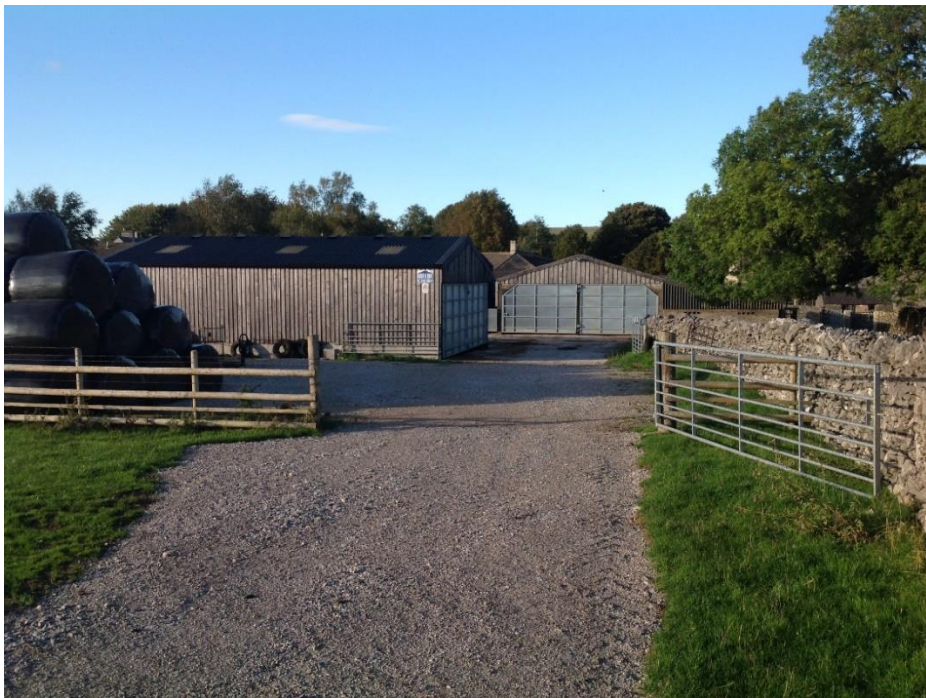
*Fig.27: the farmstead from the south, with recent sheds screening views of the older buildings (photo: Robert Hall)*

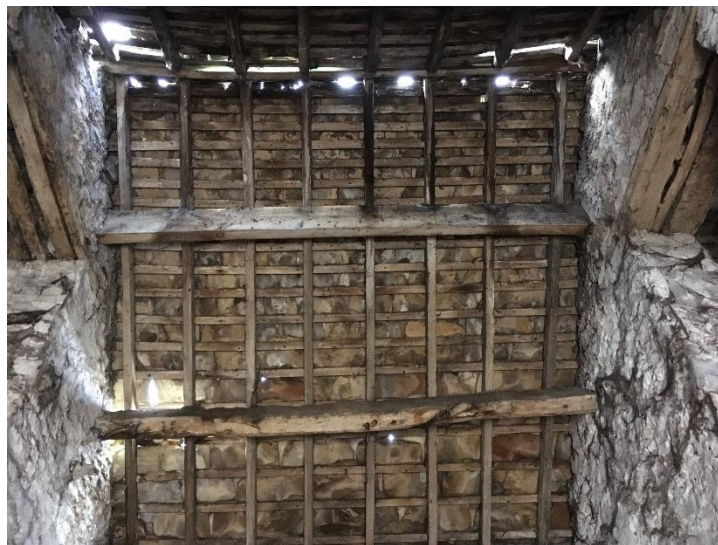
*Fig.28: typical roof - centre bay of north shippon*

2. Re-roofing using salvaged stone slates (diminishing courses) and stone ridges, over insulation. The roof will be re-laid on new battens, with insulation fitted so that the existing trusses and purlins are exposed. Rafters will be retained or replaced to match,

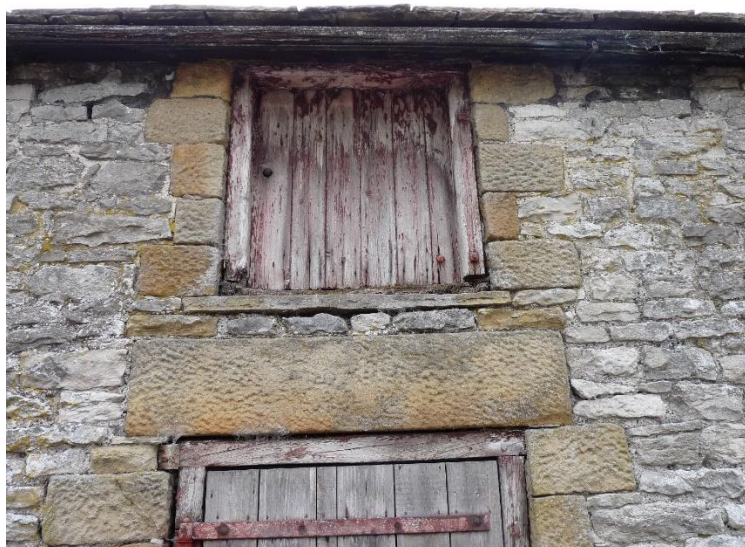
*Fig.29: shutter above doorway, south end of main range (east elevation)*

3. New timber windows are proposed in existing openings, to provide weather-proofing, natural light and ventilation. The windows will have simple painted timber hardwood frames with double-glazed units (without glazing bars). Ground floor windows will generally be 'hopper' pattern. The window details and sections are shown on drawing No.6 Rev A, by PME Planning. Insulation and a DPC are needed to all openings. Shutters are not proposed to first floor openings, as the existing shutters are hung internally (Fig.29), and it is not feasible to retain these features whilst also fitting

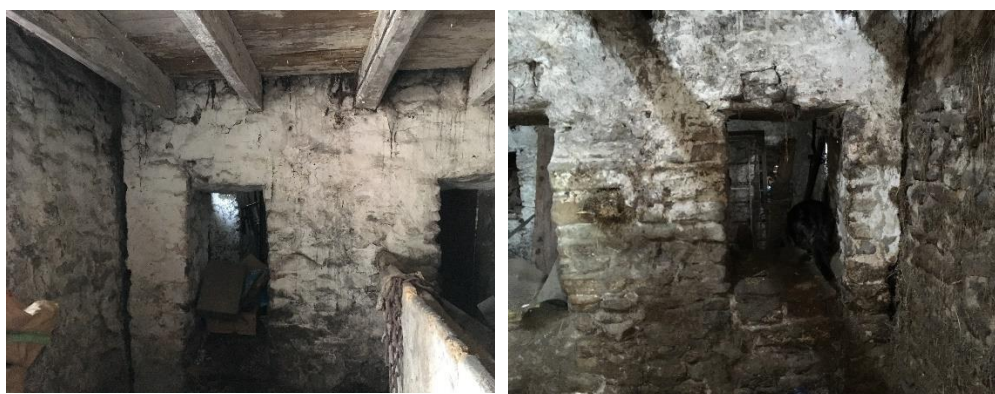
*Fig.30: proposed doorway locations in unit 1 (north wall LH and south wall RH)*

Internal doorways will be inserted in three locations, in cross walls, to connect rooms within each unit. Linking rooms is critical to the proposed use. In the north shippon of the main range, the two proposed doorways will entail the loss of one feeding hole on each of the walls that flank the through passage (Unit 3), at the east end of the cross walls. At the south end of the range, one doorway is proposed at the east end of the cross wall in Unit 2.

*Impact:* creating new doorways affects historic masonry and has a moderate impact on the historic, aesthetic and archaeological significance of the building. The two doorways in Unit 3 entail the loss of two features of some significance, but the south doorway in Unit 2 affects an area of unremarkable masonry with no features and here the impact is low.
